MATHERAN - AN ECOLOGICAL SENSITIVE HILLSTATION IN INDIA WITH POOR ROAD-INFRASTRUCTURE AND MASSIVE POLLUTION; TRANSPORT-SCHEMES; Part III

Updated by Dr. Frank Wingler, March 2019

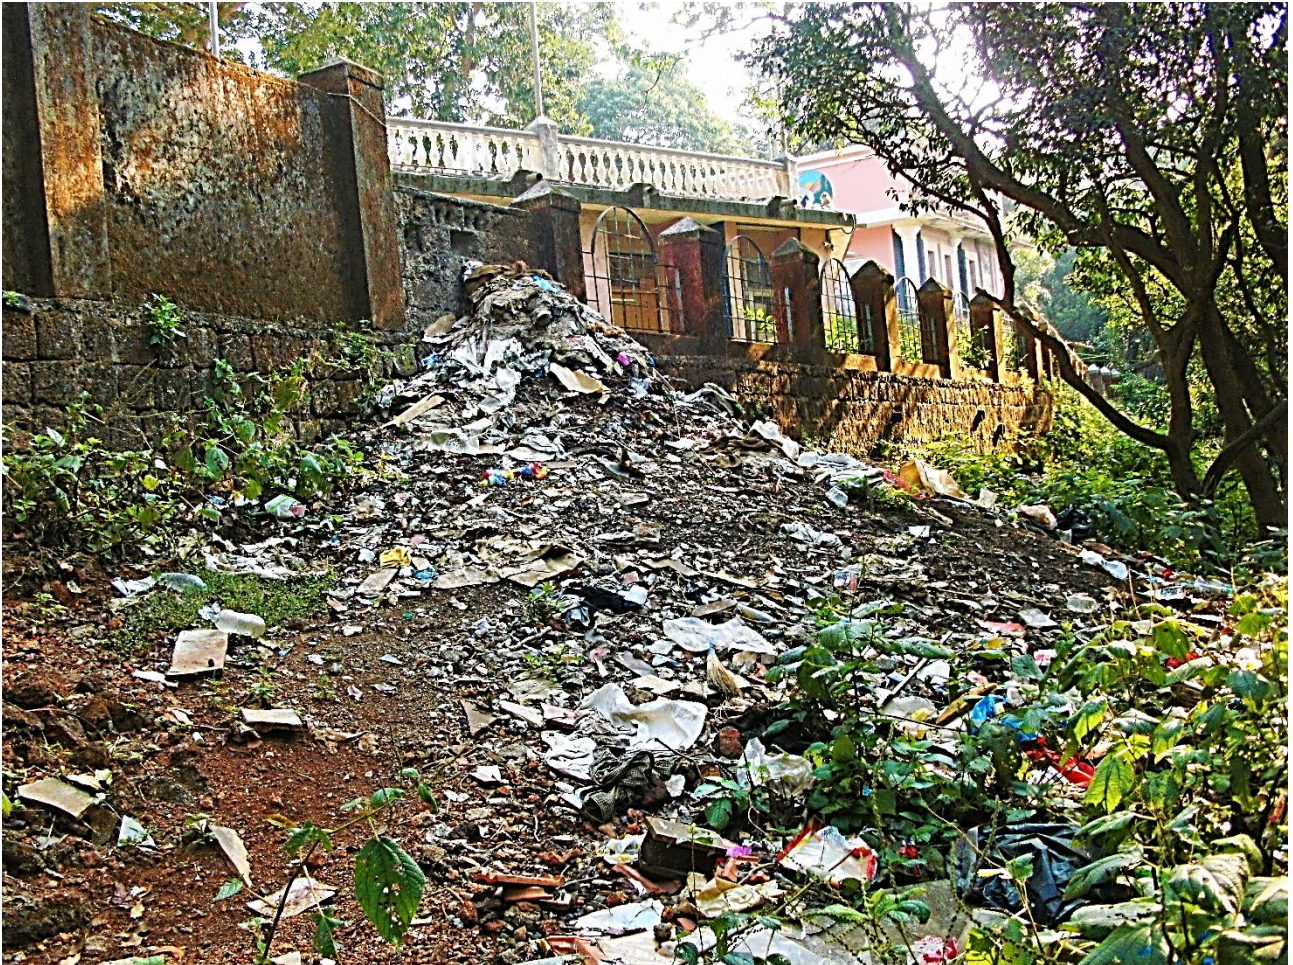
Pollution by Garbage Dump behind a 5 Star Hotel at Matheran

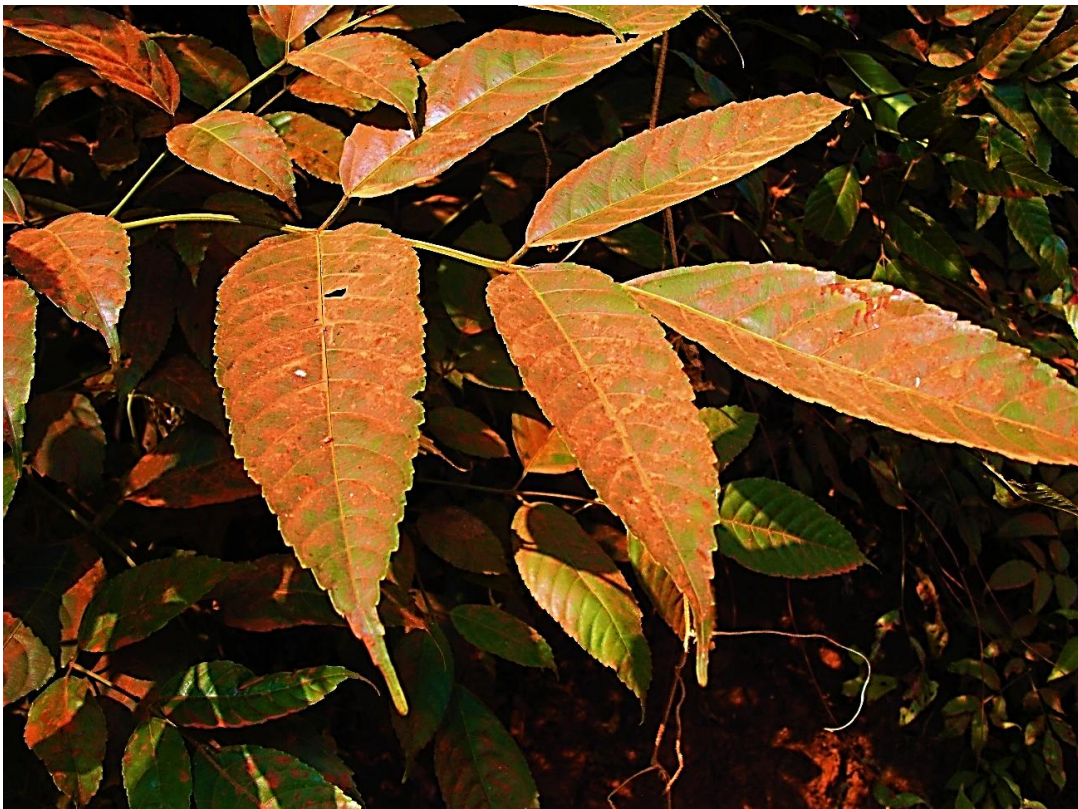
One year later in October/November 2018, no improvements could be experienced, only further deterioration detected, concerning the poor infrastructure, bad conditions of the road-access, car-park, cart-roads, market road and trails to the scenic visiting points. Visitors throw their plastic thrash still carelessly each and everywhere. During dry season the air gets heavily polluted by the red laterite-dust stirred up by the horses, staining the shops along the market road and the foliage along the trails to the points.

Foliage stained through massive Air- Pollution with red Laterite Dust stirred-up by Horses

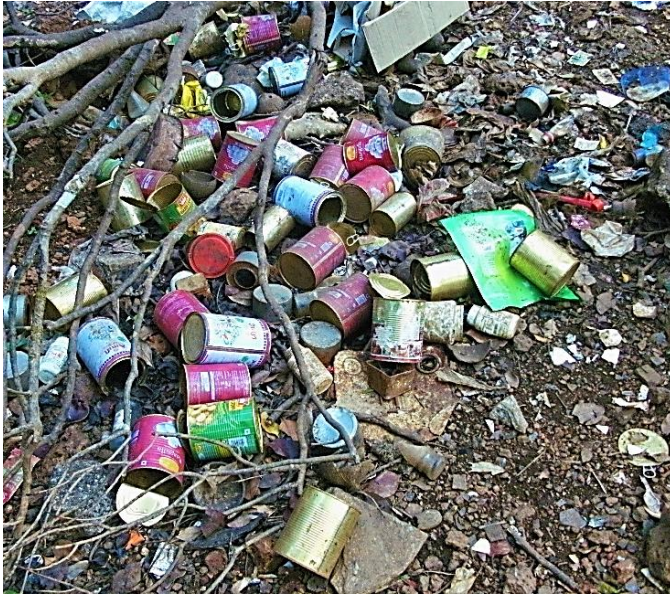
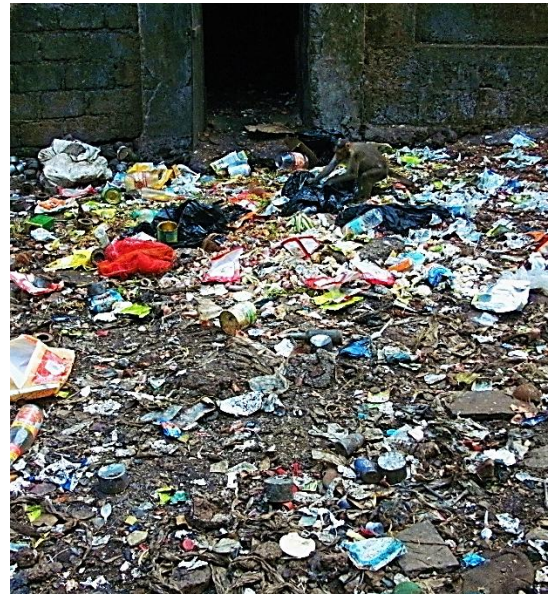
The top picture as well the following pictures had been taken behind a 5-Star-Hotel. Kitchen waste and waste water are discarded into the forest attracting stray dogs and monkeys, which in their high uncontrolled population growth are a nuisance and menace to the visitors:

Pictures taken October 2018 behind a 5-Star Hotel at Matheran

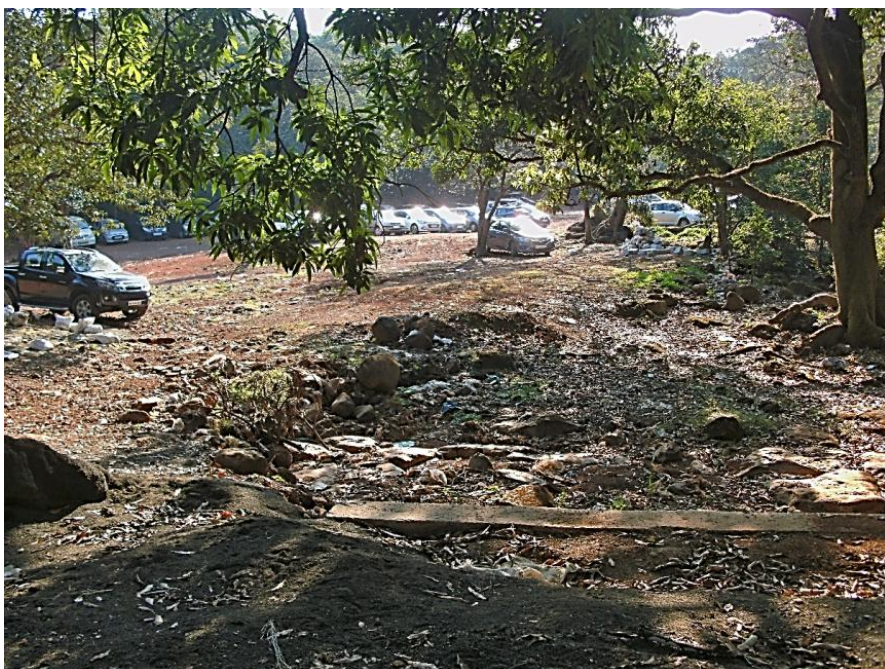
For the economic wellbeing and development of this ecological-sensitive hill-station a good road-access and a proper taxi-stand cum car-park with a road-rail hub is essential. An advisable location for a proper taxi-stand, car-park and road-rail hub could be near Dasturi, where the trees have already withered away due to the urine of the horses:

Advisable Location for a combined Taxi-Stand, Car-Park and Road-Rail Passenger-Hub

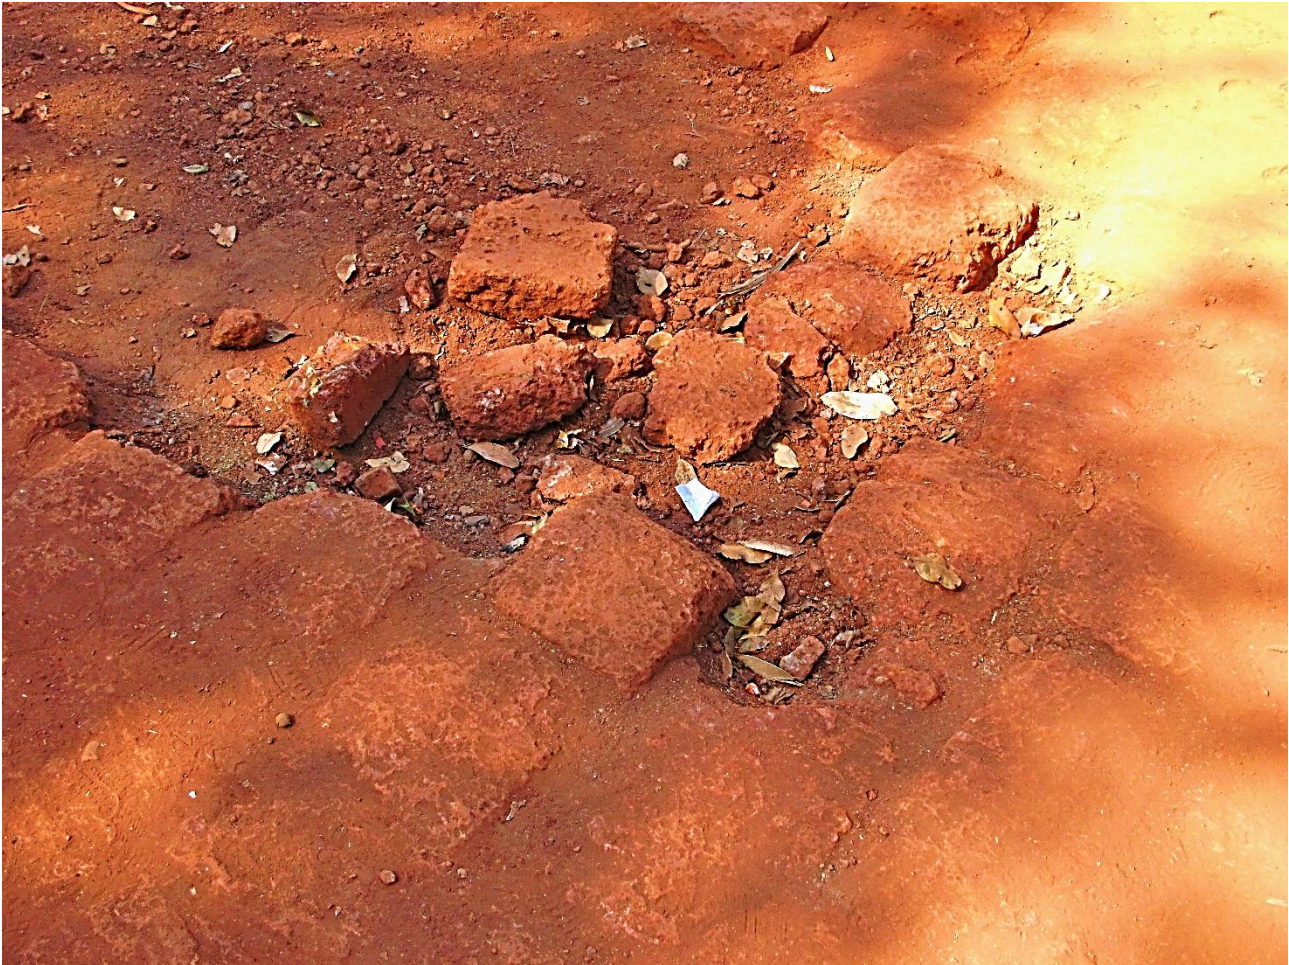
The cart-road from Dasturi to Market is in a deplorable state-of-affairs. The Market-Road is dilapidated producing during dry season red laterite-dust mixed with horse dung staining shops and affecting health of humans with no improvements since several years:

Dilapidated State-of-Affairs of Market Road without any improvements since Years

To sprinkle water by the fire-brigade on the dusty road produces alleviations only for less than one hour. Horses will ruin whatever pavement material will be used. Horses have to be banned from the road from Dasturi to the market and in the market area. **From Dasturi to market a dedicated trail for horses should be provided !.**

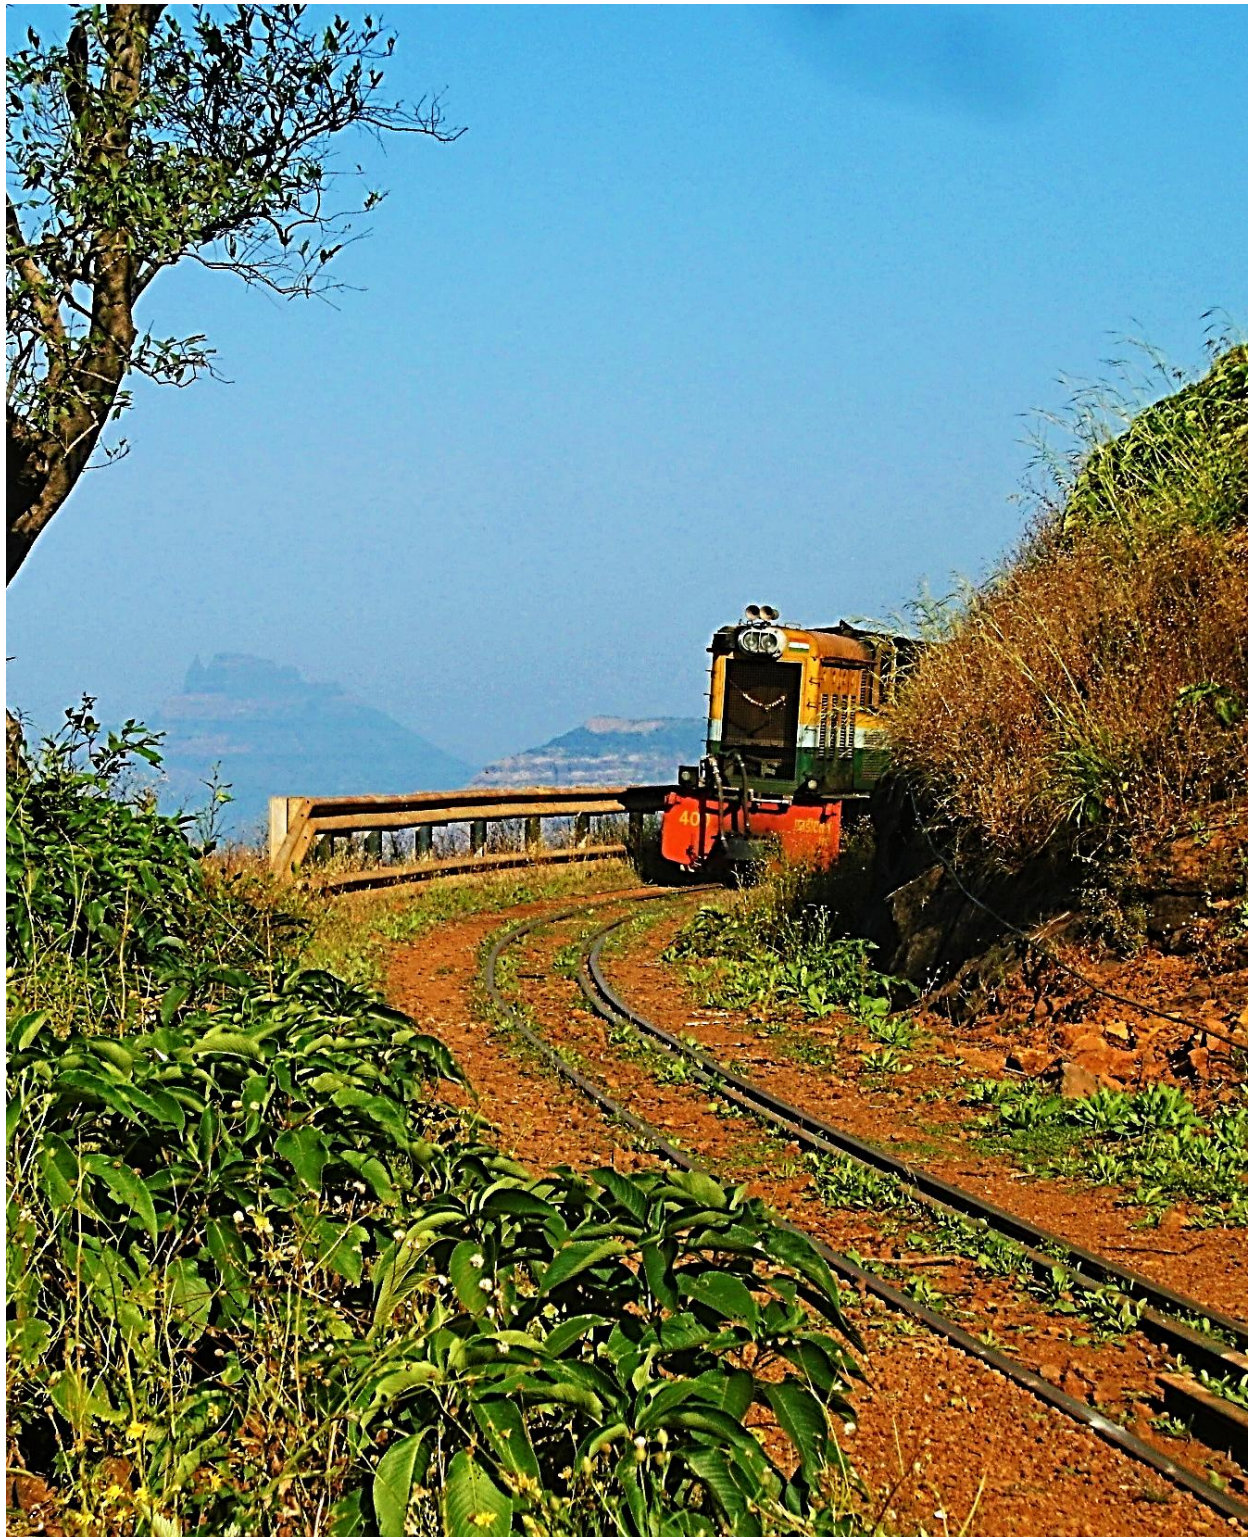
Crash-Barrier near Governor Hill (Panorama-Point Rim); but Track still in poor Condition

In November 2018 the Crash Barriers on the Section Jumma Patti to Neral had not yet been mounted.

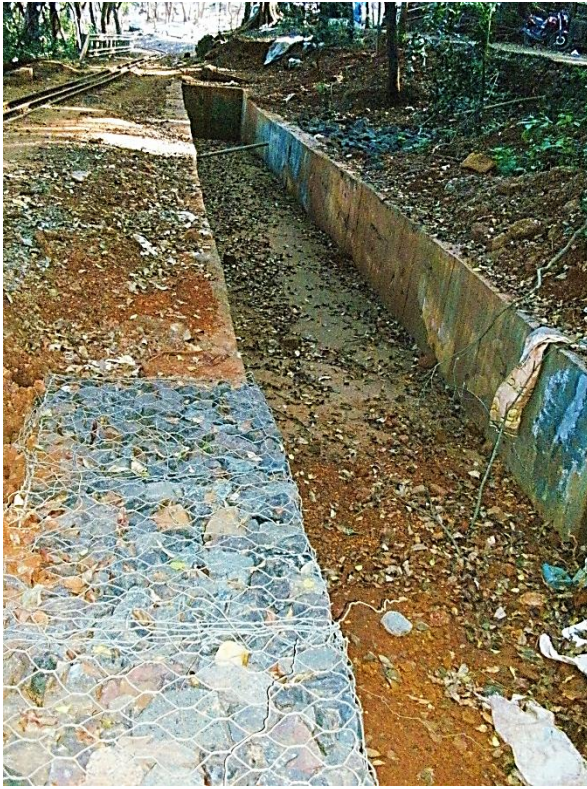
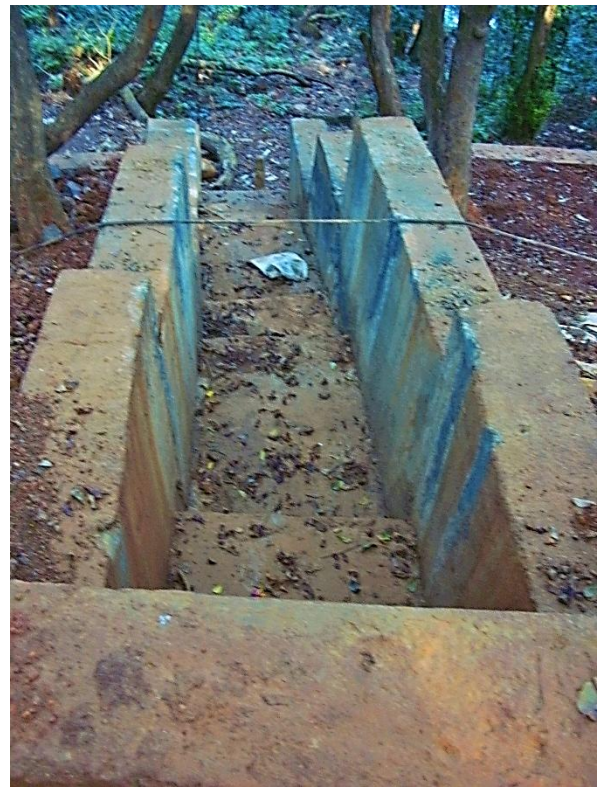
On many sections retaining walls/gabions secure now the formation and subgrade. The construction of catch-drains, gutters and culverts to secure the track against destruction by water during monsoon time is going on:

Ongoing Investments in Catch-Drains, Gutters and Culverts securing the Rail-Track during Monsoon Time

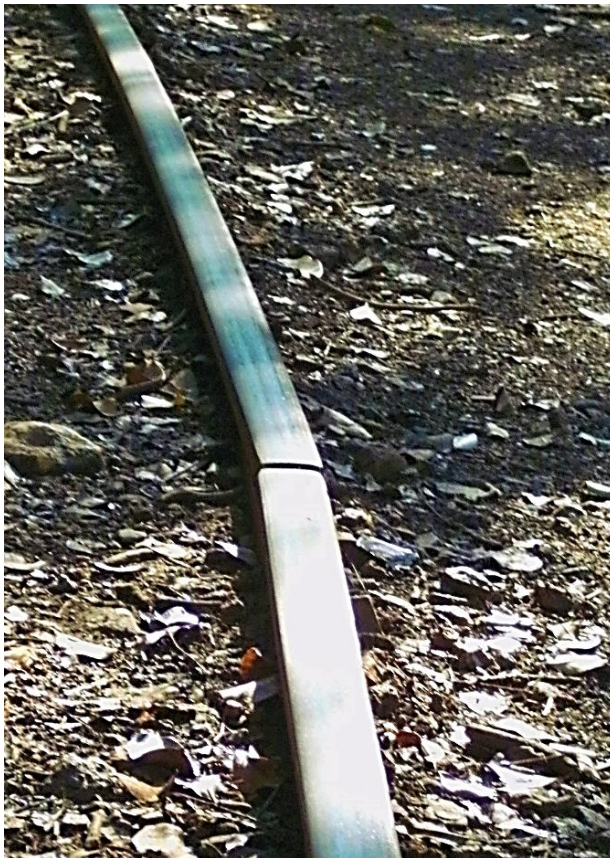
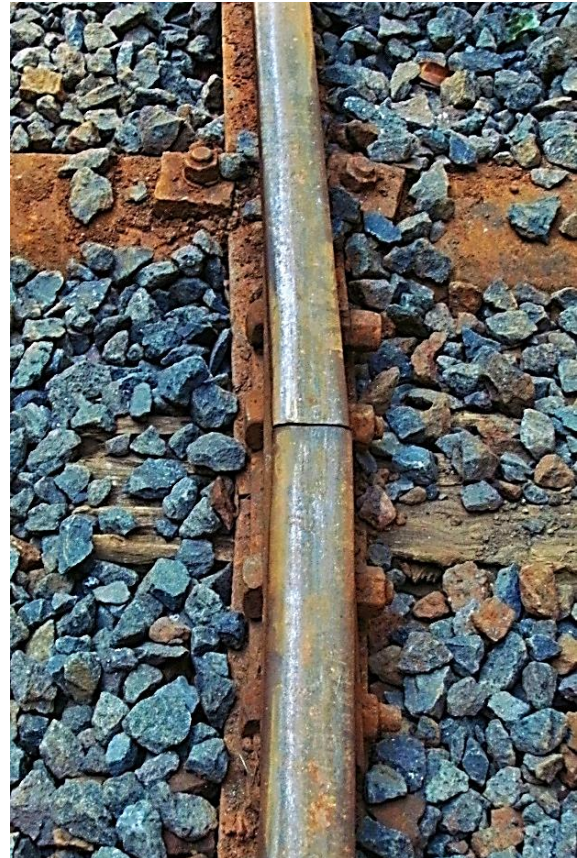
But the rails are still not in good shape. At many spots kinking rail-joints on outer curve-rails (high-rails) can be detected adding to train derailment risks:

Risky kinking Rail-Joints on outer Curve-Rails contributing to Derailment-Proneness

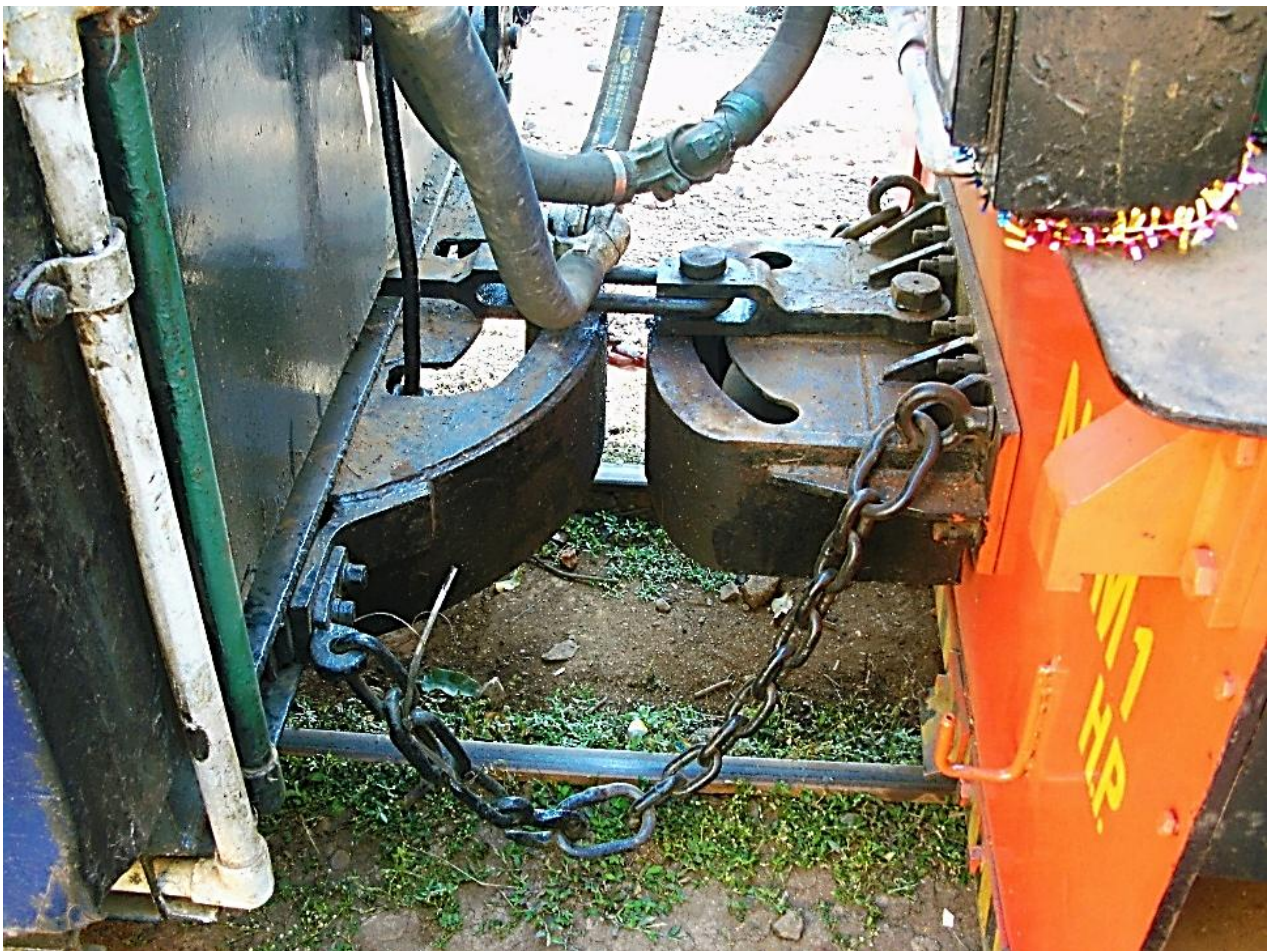
Not only the poor conditions of the rails, but also the **TRAINSET-JERK/JOLT MOVEMENTS**, inflicted by the recently installed unfavourable dual pipe compressed air-brake system in conjunction with the old primitive undamped tramway-coupling system from 1904, add to the **DERAILMENT-PRONENESS, especially on down-gradient runs when trailing on curves**. As well known amongst railway engineers, track geometry-parameter-defects, train-set jerks, sand, corrosion and solid impurities on rails as well wrong coach loading add to derailment risks.

The train-coupling system is not that of a railway but of a tramway from 1904. Between the blocks there are gaps of 2 to 3 cm, which can open or close during a train-run. On a 6 coach train-set, those gaps can sum up to about 18 cm, opening and closing without any damping:

Not Force-locking 1904 bumpy Tramway-Coupling System of Matheran's Toy-Train

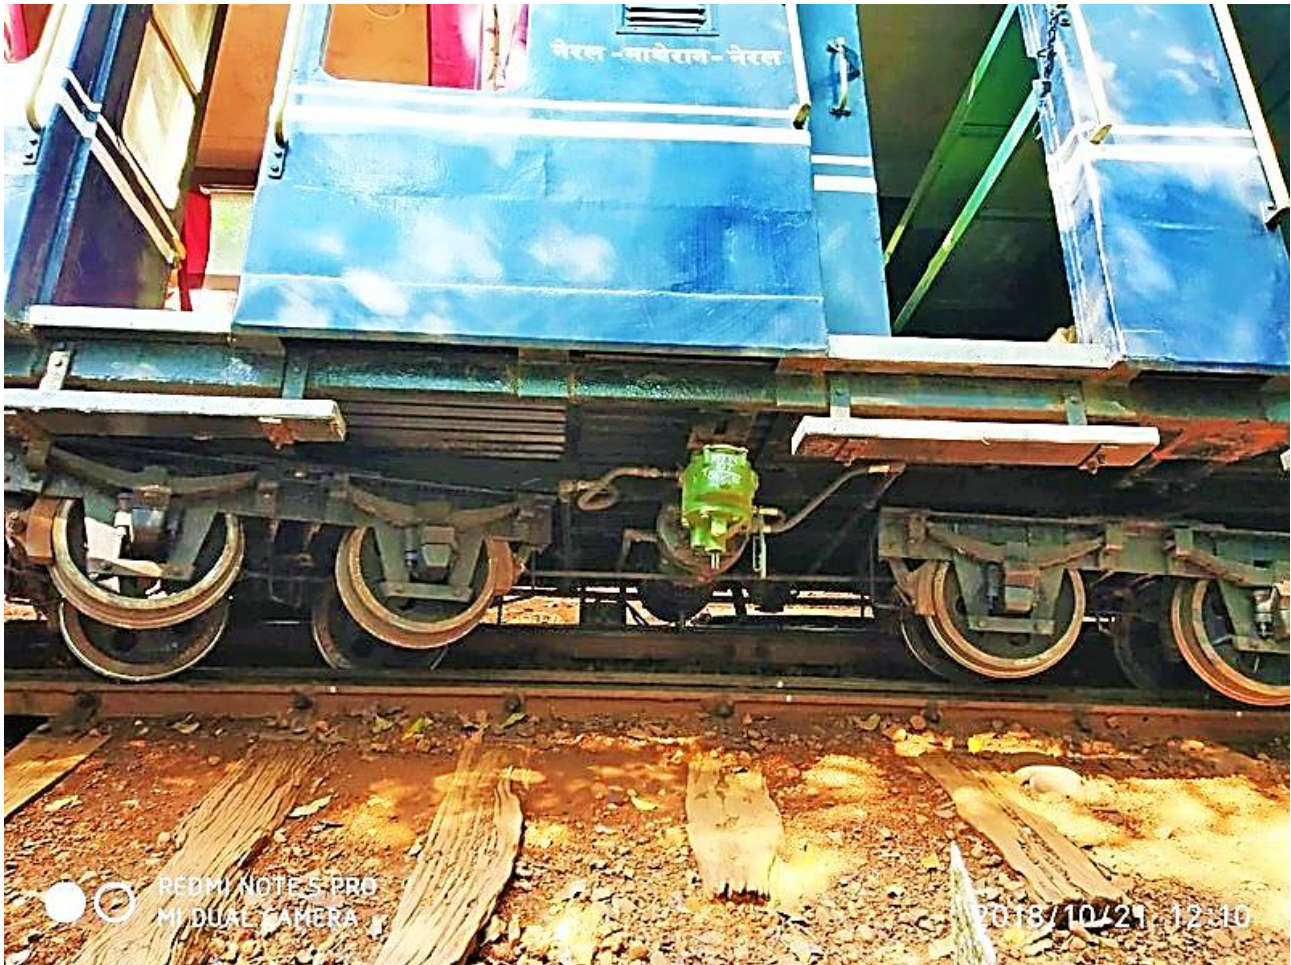
The mentioned derailment-proneness factors might have come together on Sunday 21st. October 2018 at noon, when a parcel-van of the shuttle-service derailed near Aman Lodge on a poor aligned turnout (see also: **MATHERAN'S TOY TRAIN, THE JOY AND PRIDE OF TOURISM IN MAHARASHTRA, INDIA, UNDER SAFETY SCRUTINY**; published on: [November 11, 2017](#) & [December 10, 2017](#); free for download from <http://www.drwingler.com>). The passengers in the adjacent coaches had a narrow escape since luckily the derailed parcel-van did not pull down the passenger coaches. Under modern **Safety and Risk Management** aspects, this unwanted bad event has to be investigated and treated as a **"NEAR MISSED BAD EVENT"** and therefore as an **"ACCIDENT"**! Lessons have to be learned.

Shuttle-Service Parcel-Van slow-Speed Flange Climbing Derailment on poor Quality Turnout at Aman Lodge; 21-10-2018 – a “Near Missed Bad Event” with a narrow Escape for Passengers

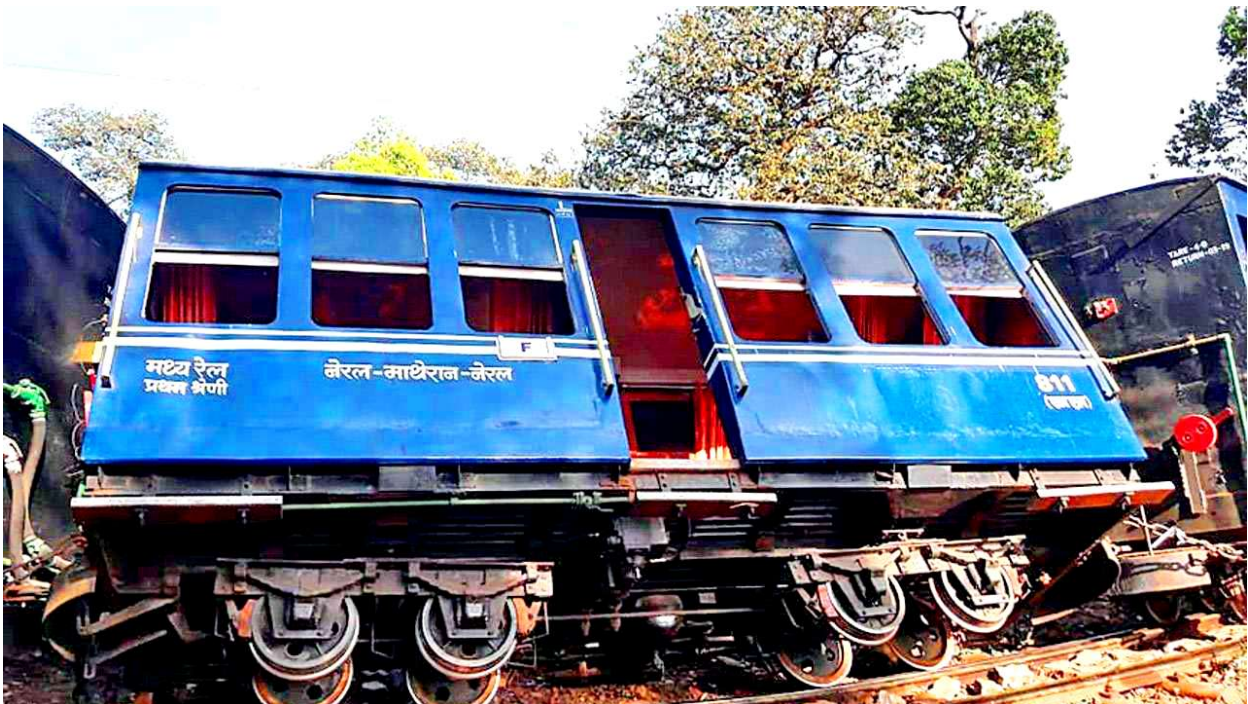
Post Scriptum: In the periode from October 21th to December 31th 2018 the Matheran Hill Train faced **FIVE DERAILMENTS!!**

**Five Derailments on Matheran Hill Train within 10 Weeks in 2018;
Track Off-Loading Derailment, December 2018**

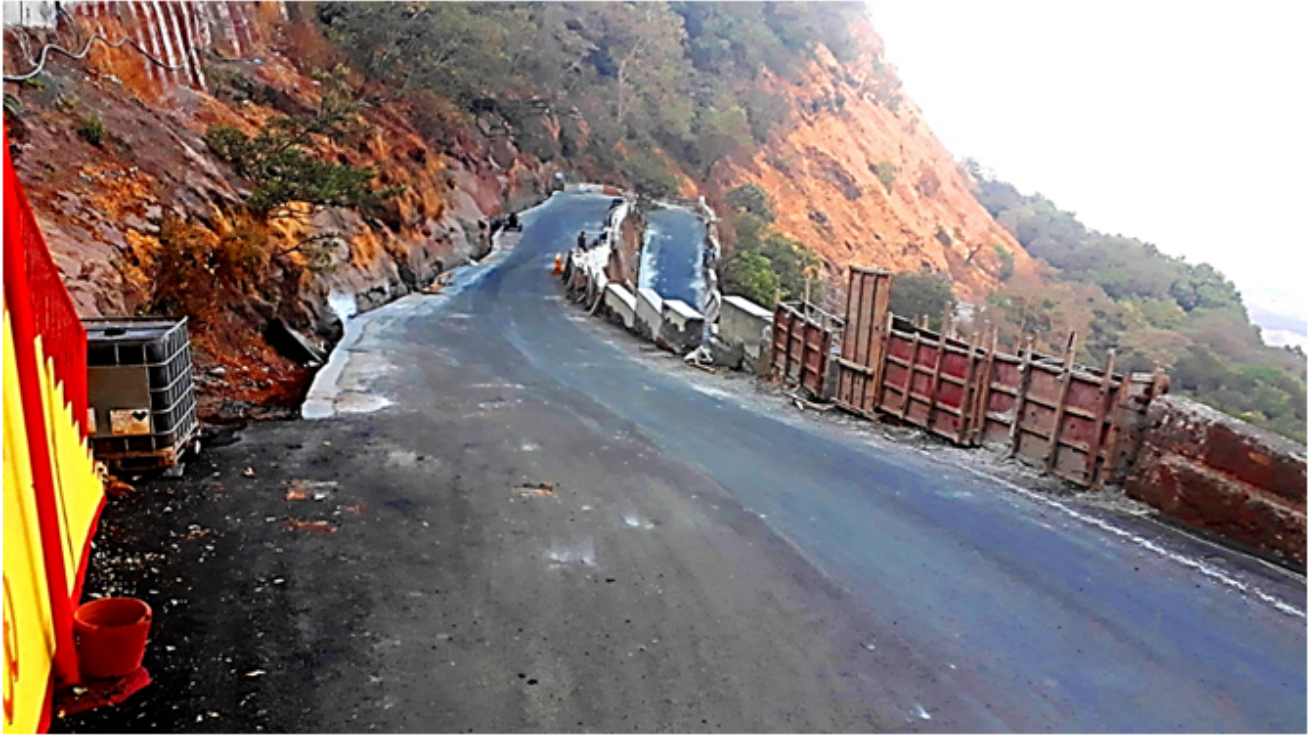
**Upper Section of the *"ONLY-ONE-ROAD"* to Matheran,
currently under Refurbishment; Pict. by N. Savant, Feb.
2019**
