# **Matheran`s Toy Train - the Joy and Pride of Maharashtra, India**

## **Goodbye to Matheran's Toy Train?**

**Feature Article by  
Dr. Frank August Wingler, Germany**

**Matheran October 2016  
Revised November 2016**

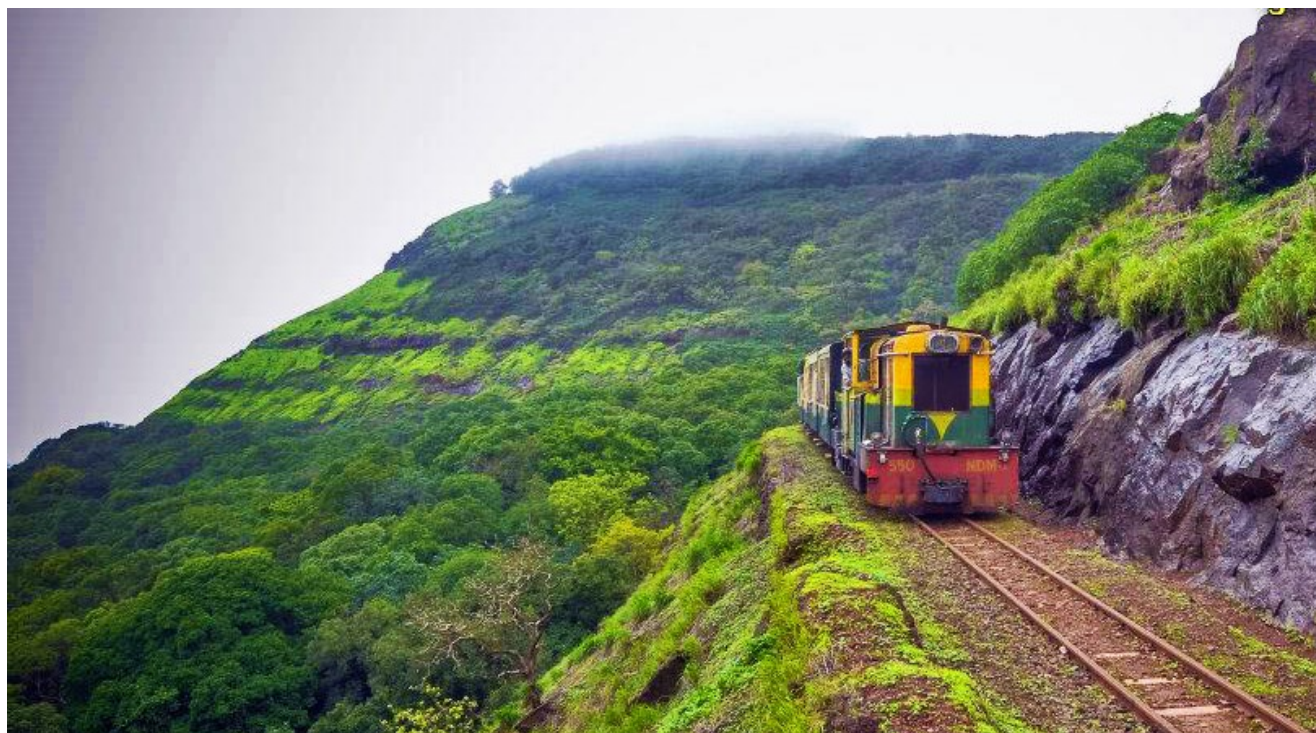
Chuckling around Panorama Point on the Abyss without any Protection Wall and without any Protection Guard-Rail to prevent Derailments and Coaches to tumble down the Precipice

- ◆ to safeguard trains on traces alongside of precipices sturdy retaining/barrier walls, preventing derailed rolling stocks to tumble down the abyss, have to be erected,

- ◆ or alternatively the track has to be shifted to the hillside and conducted in protection-galleries,
- ◆ the rolling stocks have to be provided with jerk and shock absorbing couplers; see page 14,

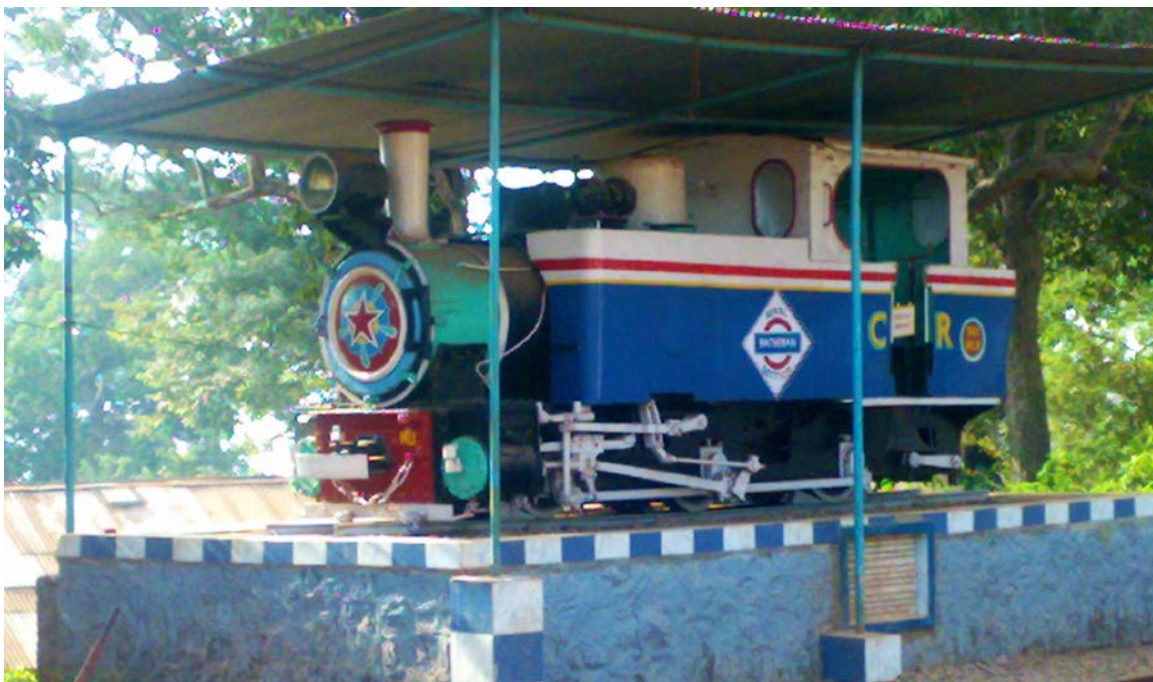
A "carcasses" of Steam Locomotive No. 741 is exposed at the Matheran Station on a pedestal:

Steam Locomotive No. 741 exposed at Matheran Station

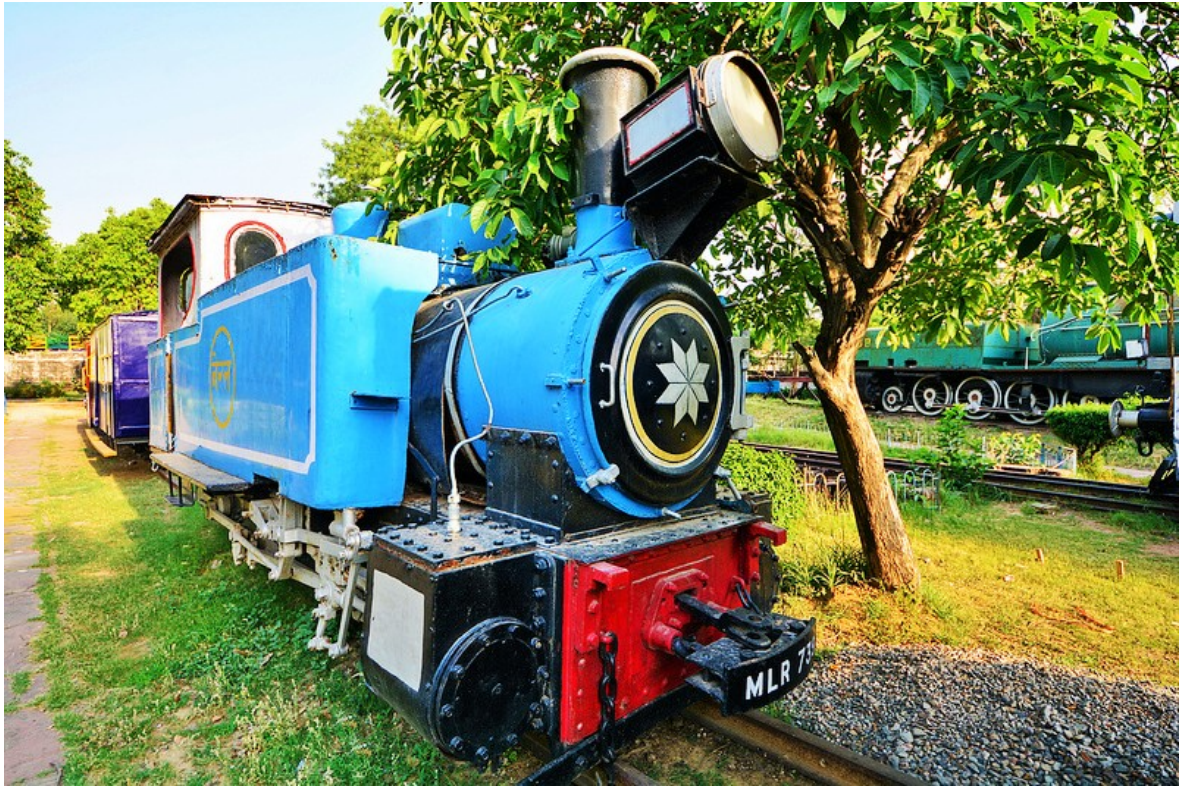
Steam Locomotive No. 739 at Delhi National Rail Museum

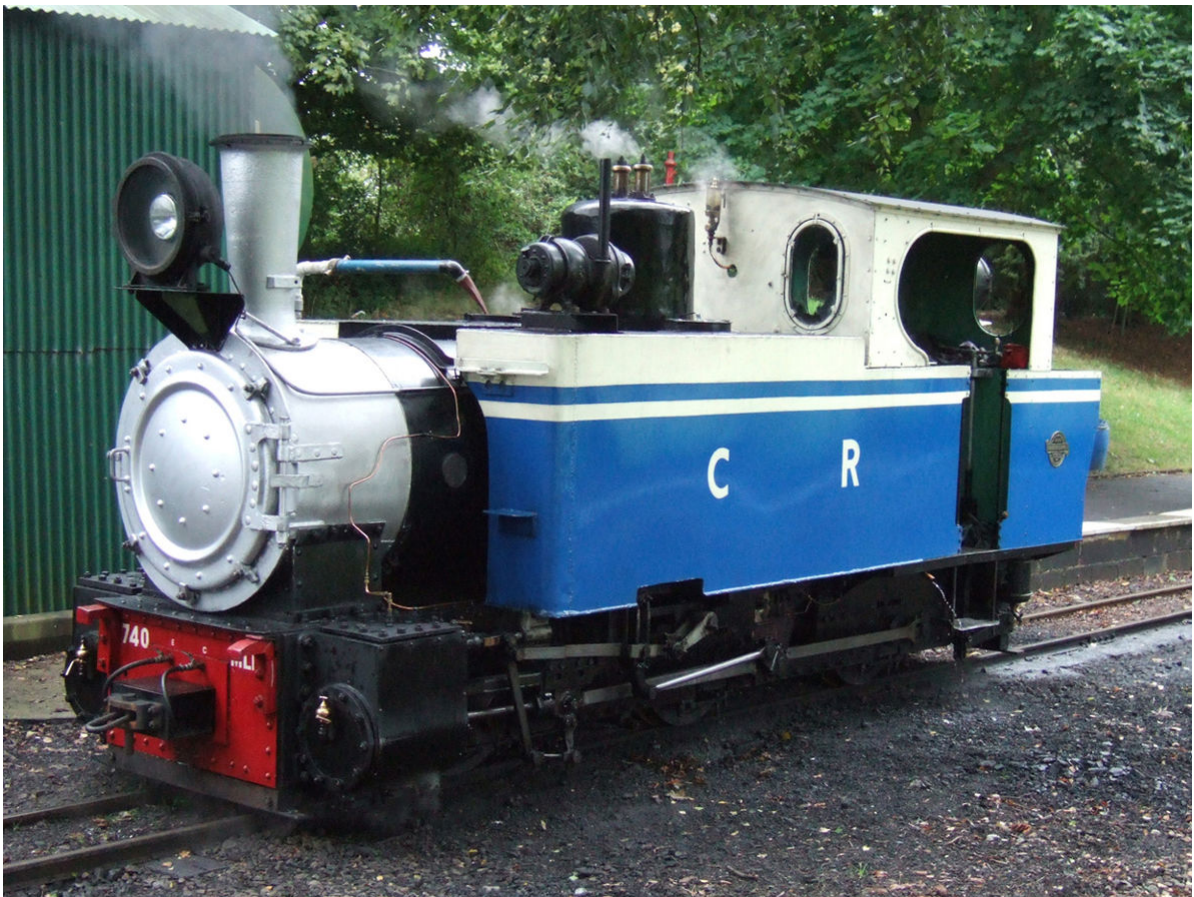
Steam Locomotive No. 740 at Leighton Buzzard Narrow Gauge Railway in Bedfordshire, England

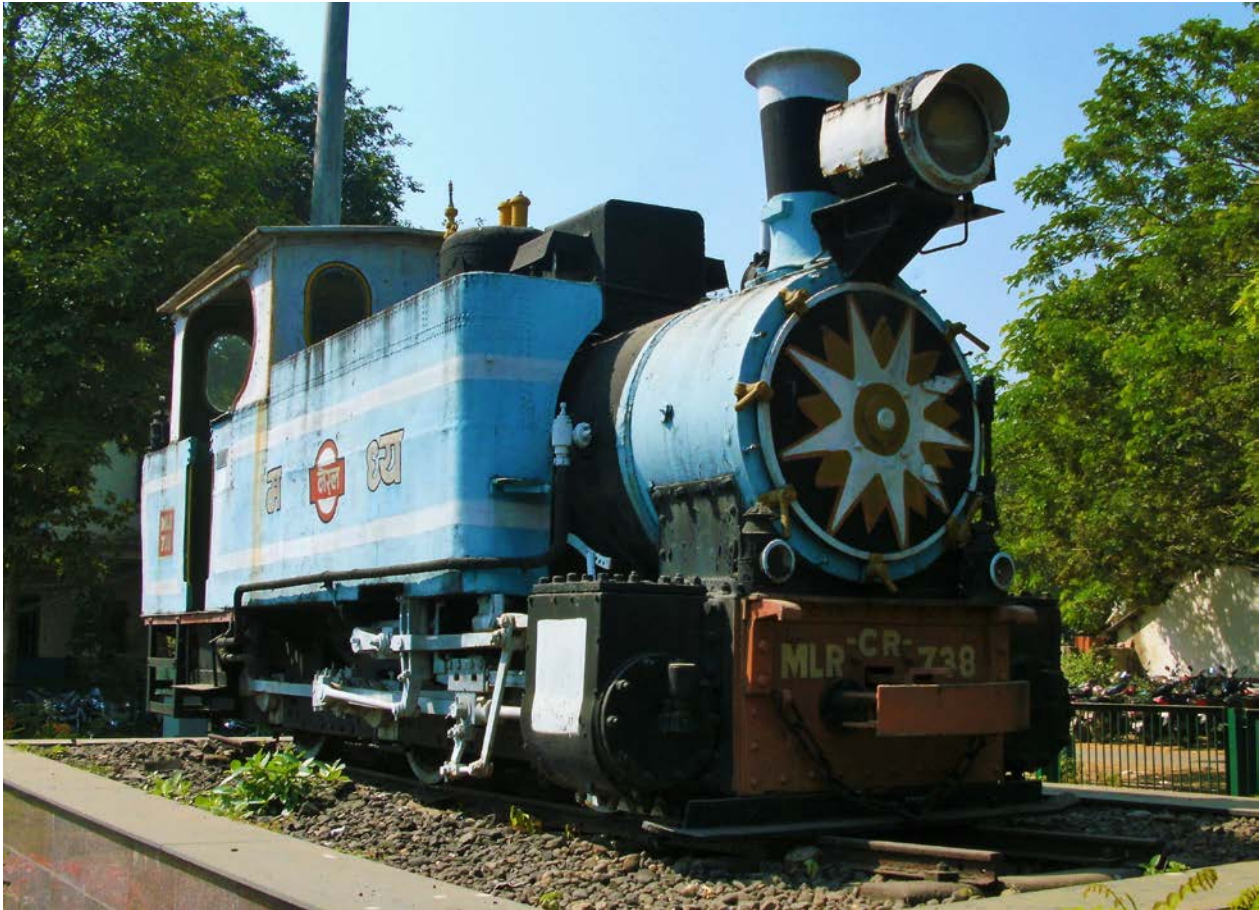
No. 738 had been 2013 restored at Parel Workshop of Central Railway. After few nostalgic test-runs on the hill section, it had been found as too difficult to run this rehabilitated Steam Locomotive with skilled personnel. The forest department did not allow to run any more a

fired steam Locomotive The locomotive is now resting exposed to the corrosive weather conditions on a pedestal at the Neral loco-shed.

Steam Locomotive No. 738 exposed to Corrosion on a Pedestal at Neral

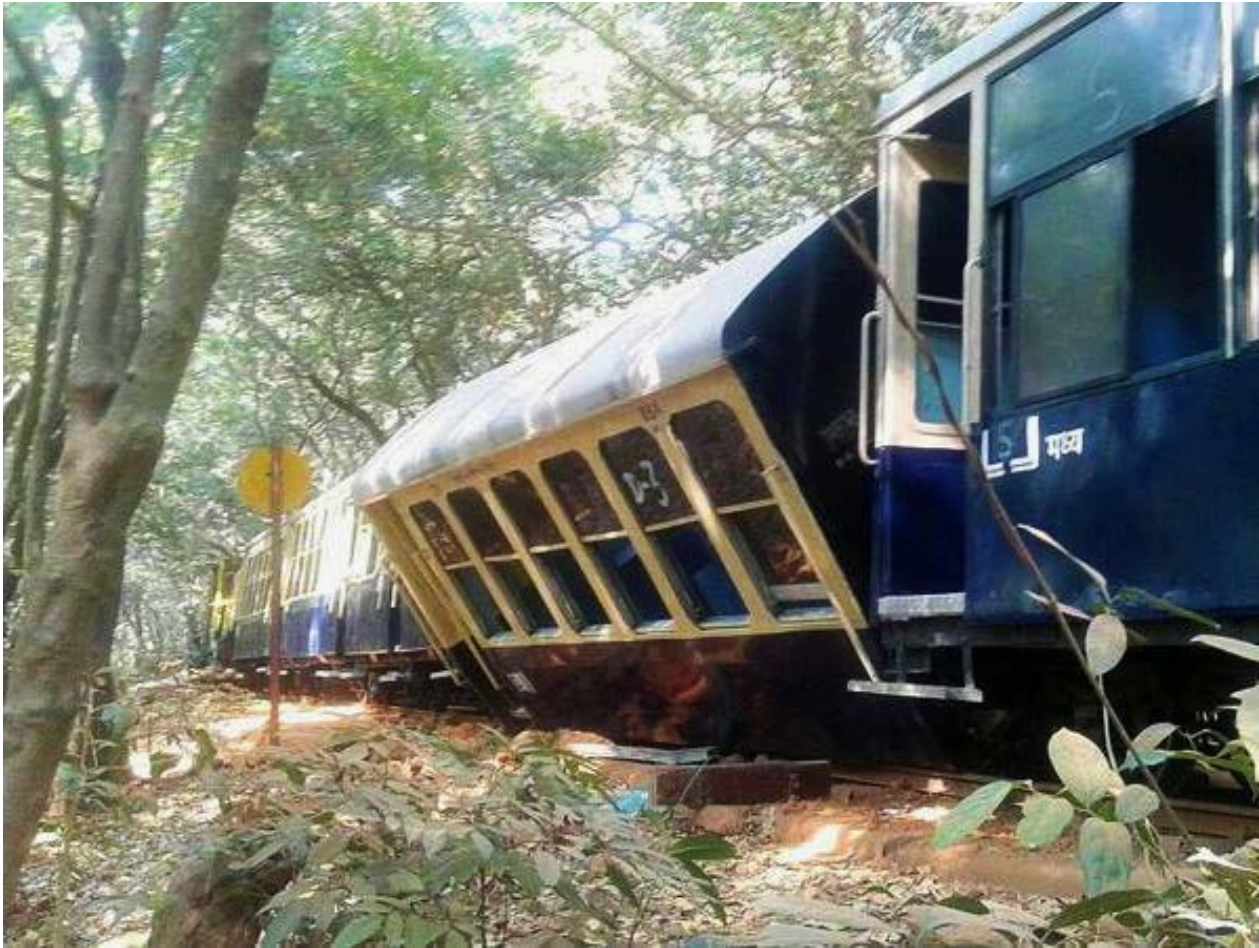
Matheran's Toy Train Coach-Derailment near Aman Lodge; 01. May 2016

The May 2016 Aman Lodge Coach Derailments show all signs of a so-called “**SLOW SPEED FLANGE CLIMBING DERAILMENT**”; see **Chapter 20.2: “DERAILMENT INVESTIGATIONS AND MECHANISM”** in the internet Publication **INDIAN RAILWAY TRACKS – A TRACK ENGINEERING COMPENDIUM**; free for download from <http://www.drwingler.com>, and the affiliated literature.

A Slow Speed Flange Climbing Derailment may occur, when several shortcomings come together as there are:

**Track Misalignment (Geometry) Parameters, worn Wheel-Treat Profiles, Train-Set Jerks, Sand or Dirt at the Rail Running Corner, corroded or rusted Rails.**

If such parameters come together a derailment might be triggered off. To mitigate derailment proneness, train-set **JERKS** should be avoided, Rails kept clean and running corners in curves lubricated.

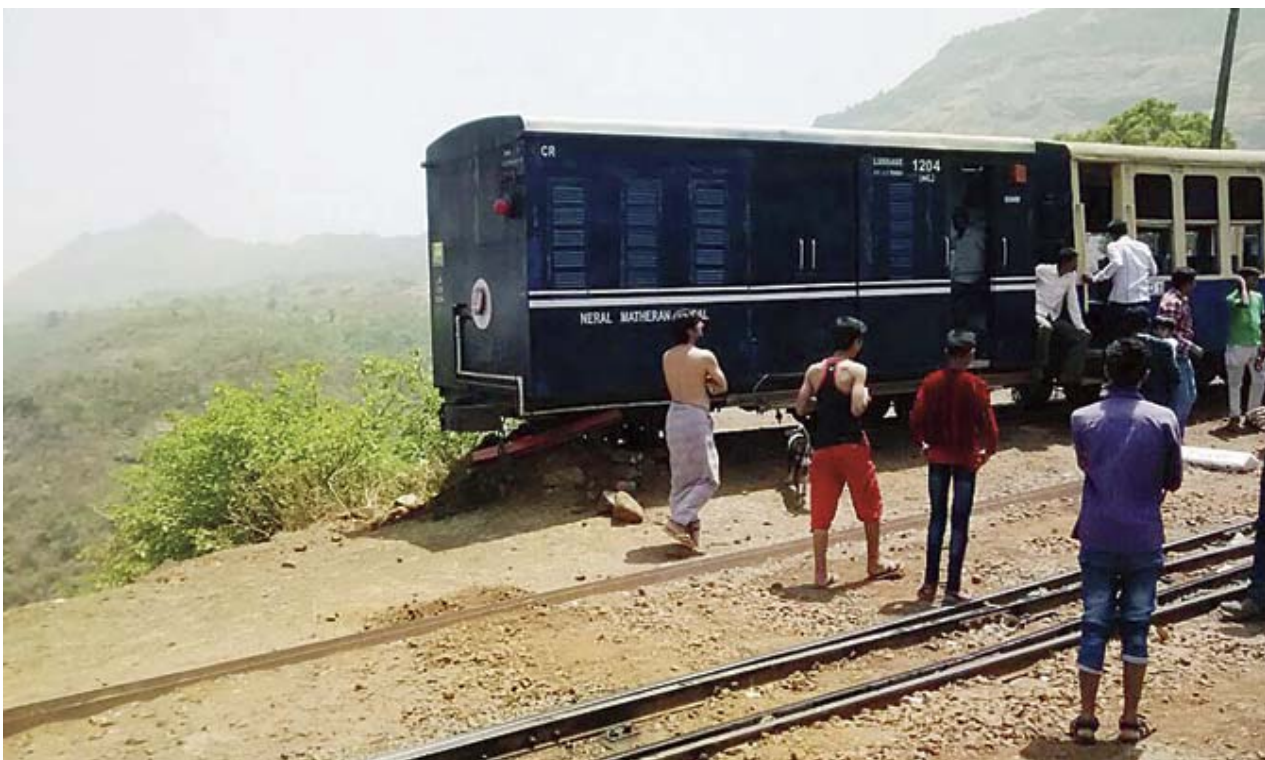
Narrow Escape for Passengers at the Abyss at Jhumpati, 26. April 2016

or even can forget to apply the brake as at the Jhumpati incident of 26<sup>th</sup> April 2016.

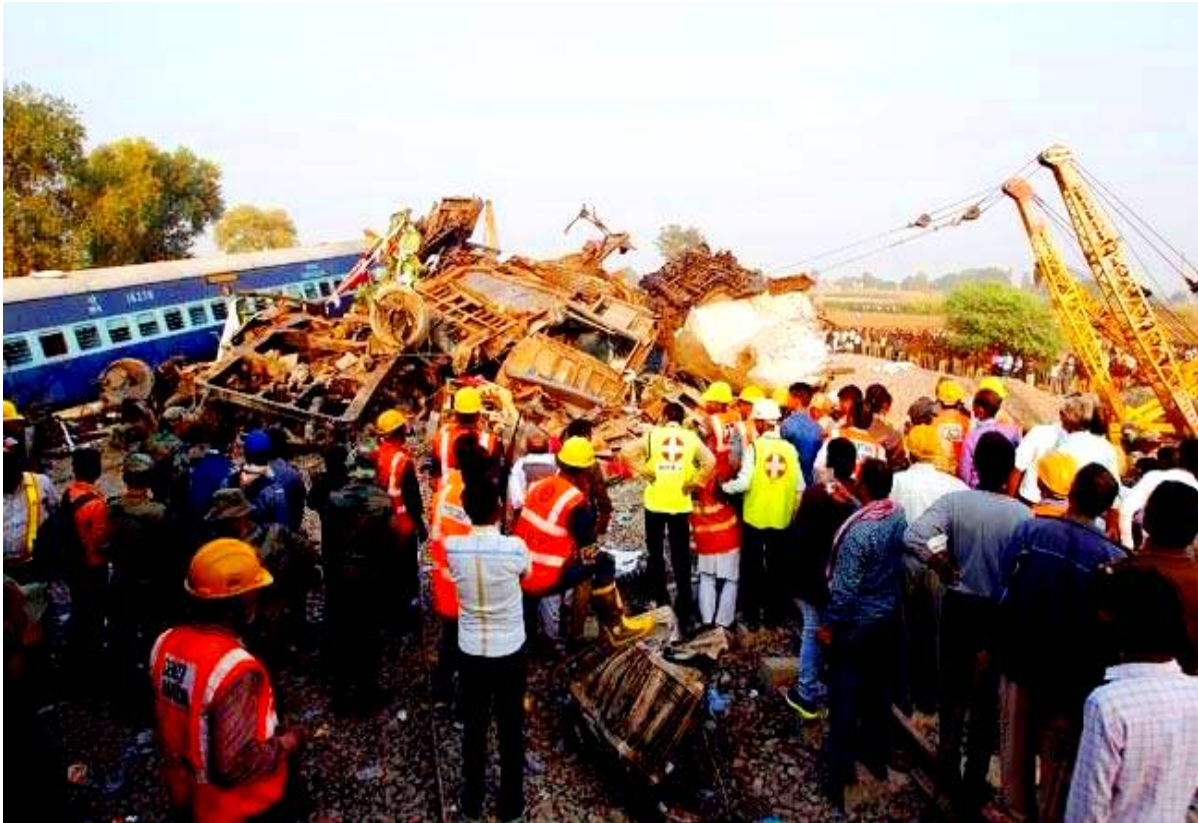
Derailed Indore Patna Express 19313 at Pukhrayan near Kanpur

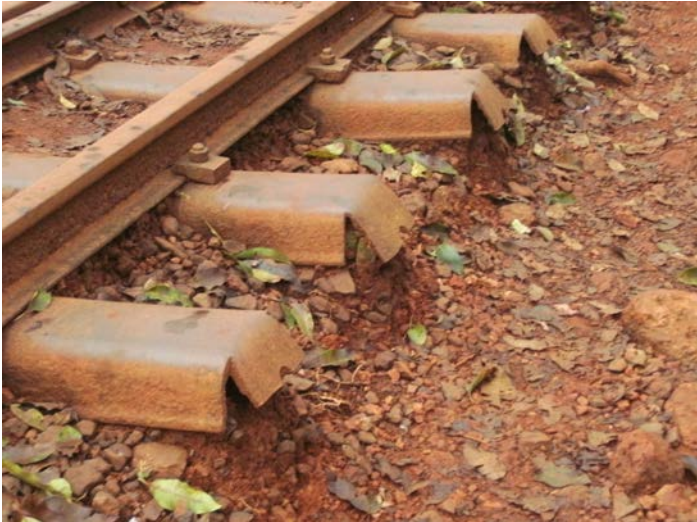
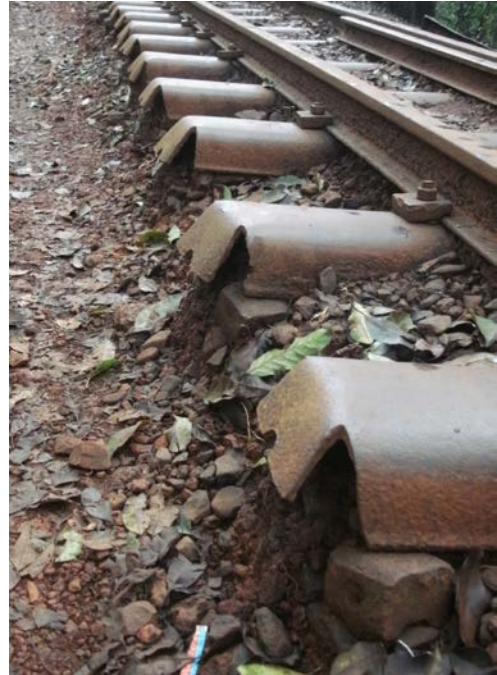
The April/May 2016 incidents on the Matheran Toy Railway show that this system is not safe and is derailment prone. Luckily the passenger coaches did not tumbled down the precipice or capsized, since at the derailment spot there had been a rudimentary formation. On other sections there is no ballast, and the formation has been swept away by water or trampled down by pedestrians using the rail track as a trail or foot path as delineated by the following pictures:

Formation and Ballast missing along the Track

The Steel-Trough Sleepers are mostly laid on mud and red earth instead on a 6 to 7 inch clean un-fouled ballast cushion, making it difficult to maintain properly the track alignment.

- ◆ the rail-track has to be brought on a well-drained stable formation with a top formation width of about 5.50 to 6.00 metre with the trough steel-sleepers resting on a clean, un-fouled 6 to 7 inch ballast-cushion,

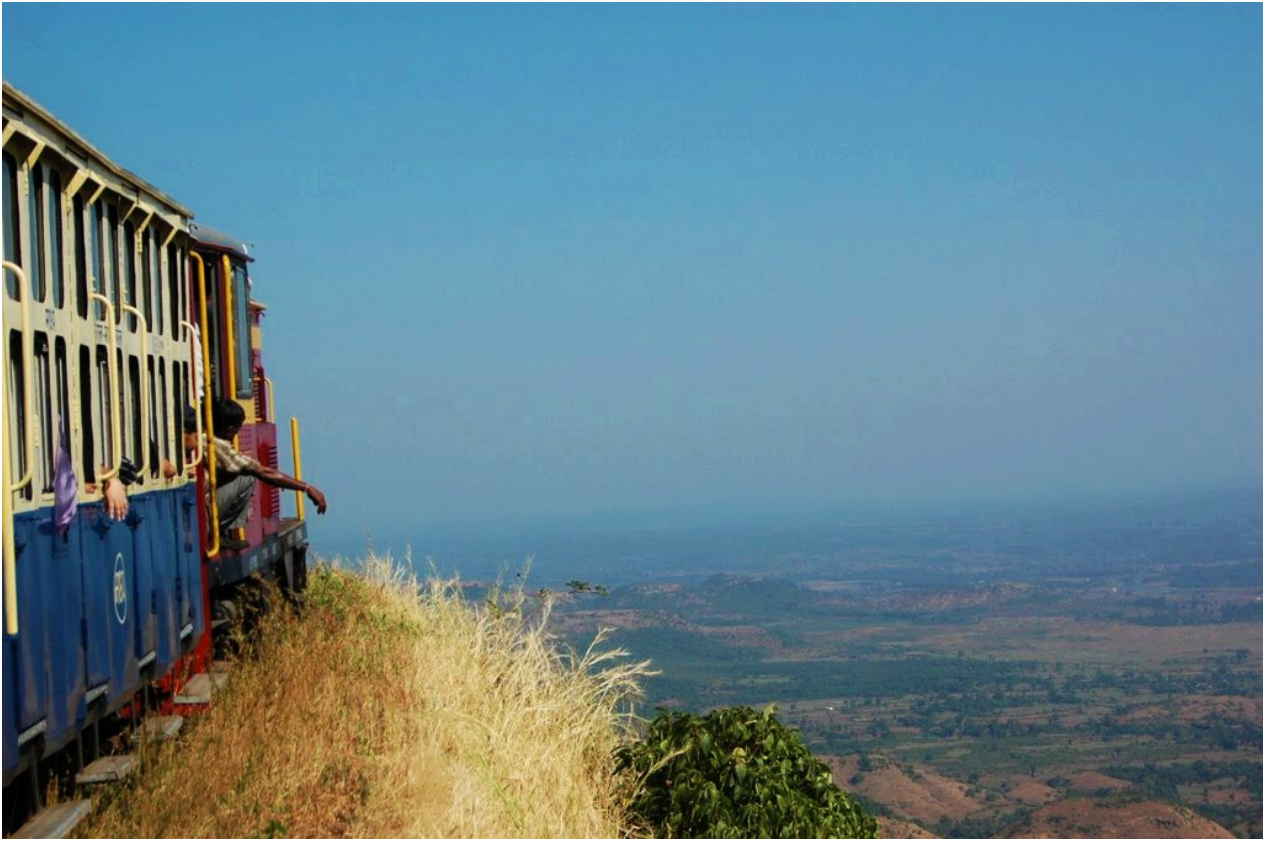
Chuckling at the Abyss without any Protection Devices

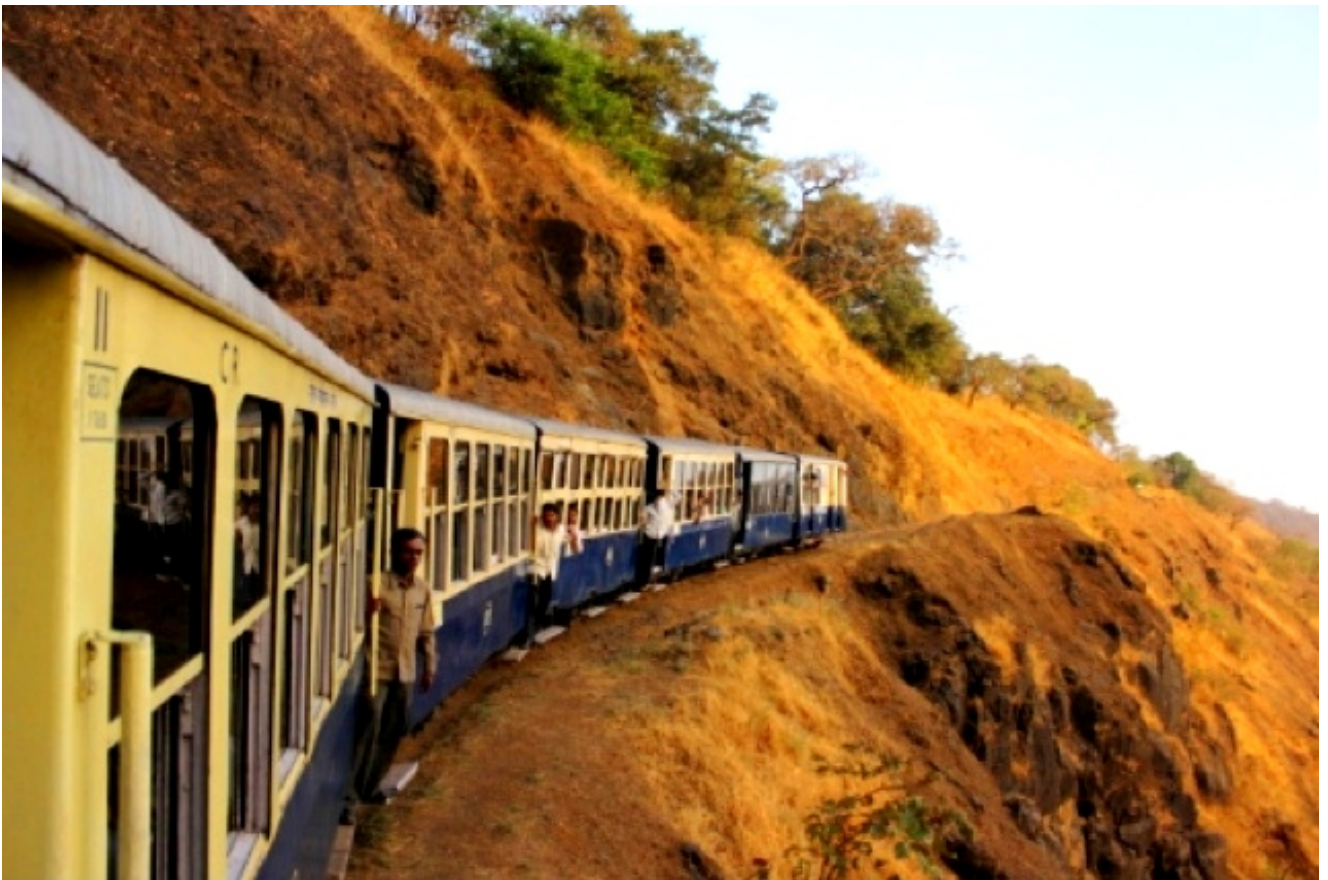
Chuckling around Panorama Point at the Abyss without any Protection Devices

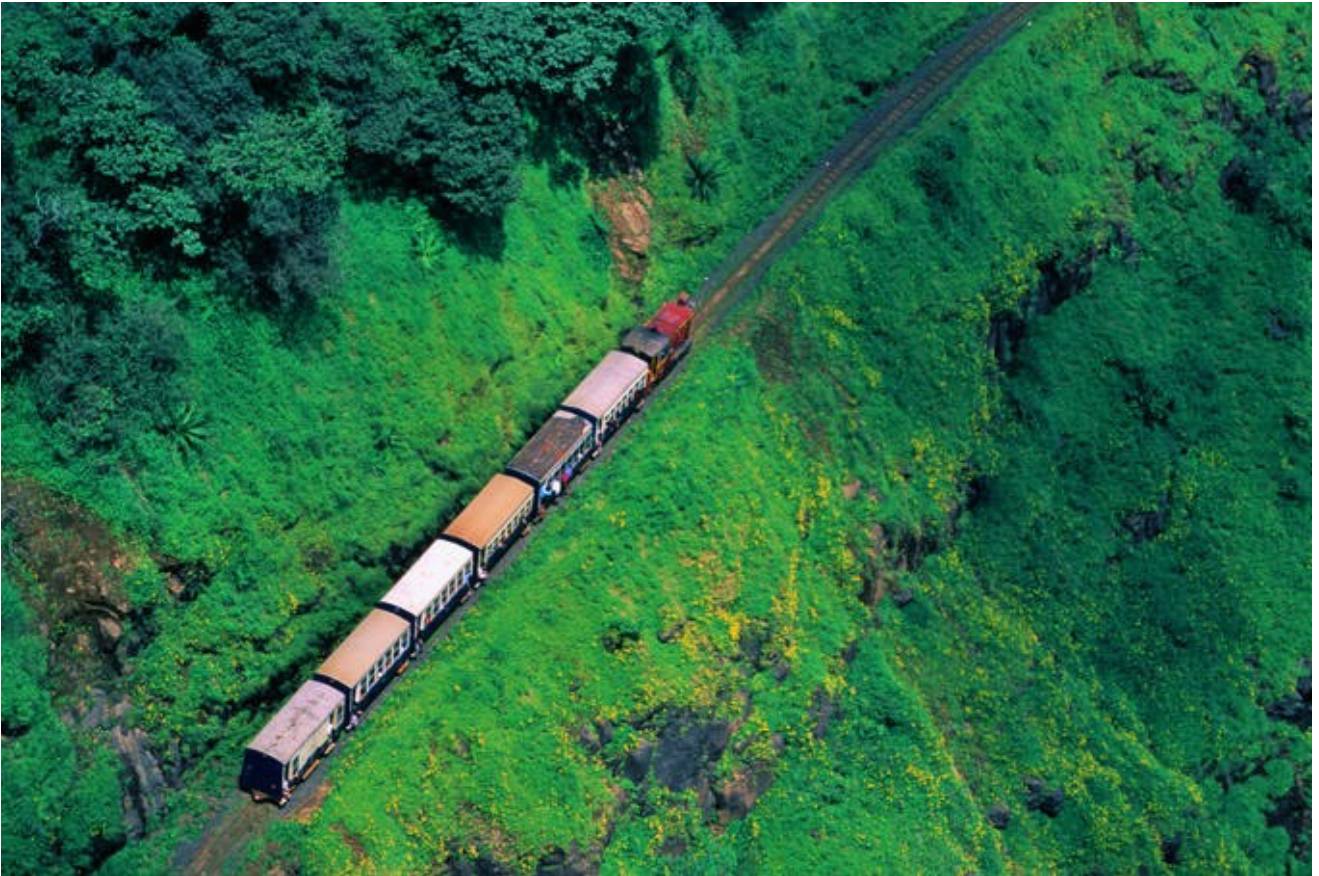
Chuckling around Panorama Point at the Abyss without any Protection Devices

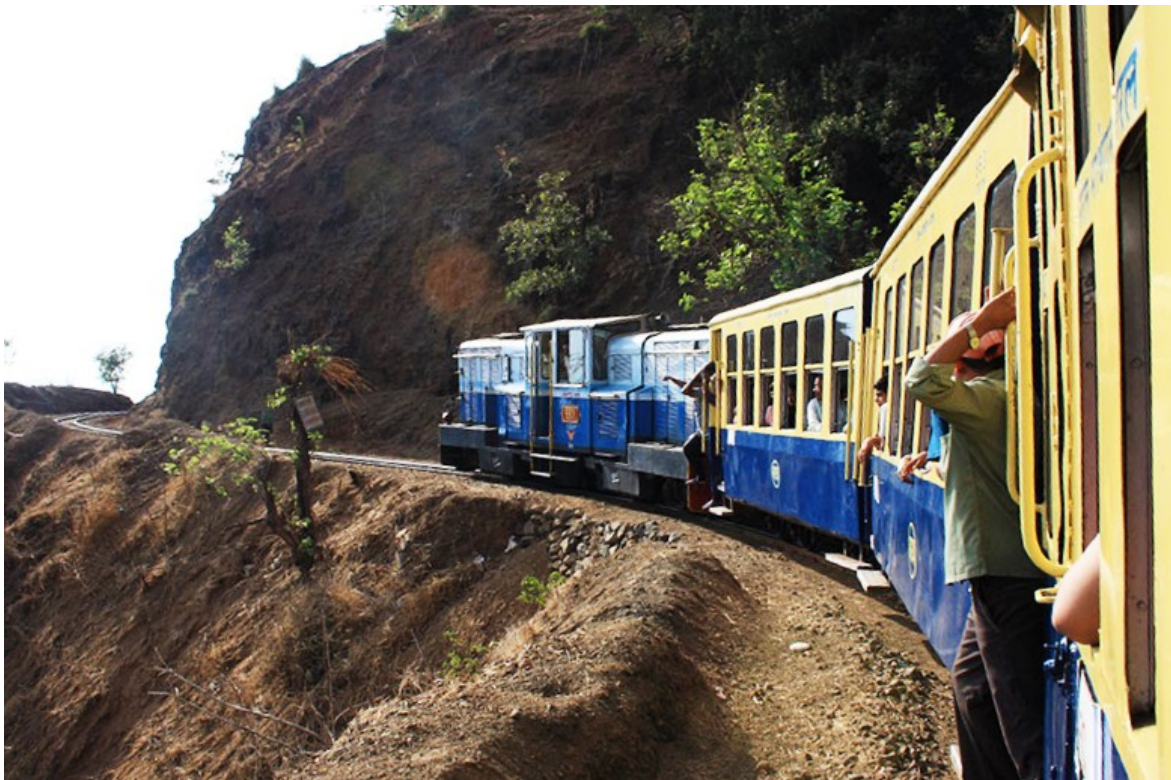
Chuckling around Panorama Point on the Abyss without any Protection Wall and without any Protection Guard-Rail to prevent Derailments and Coaches to tumble down the Precipice

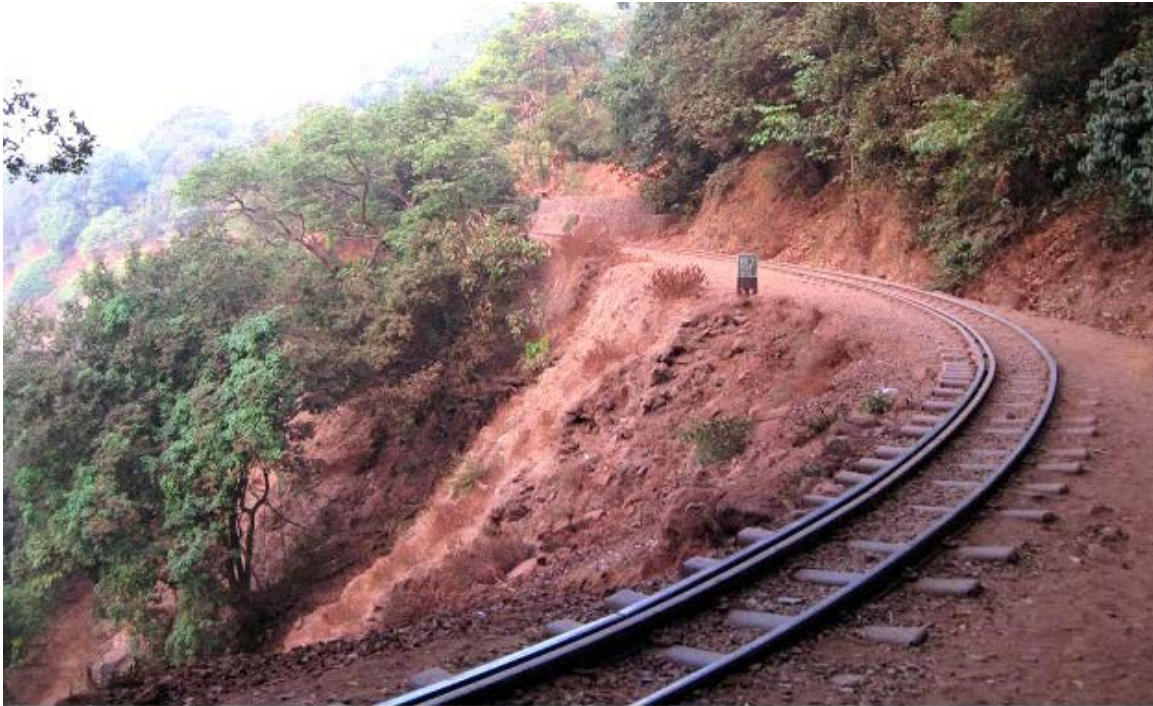
Formation flowing down the precipice between Aman Lodge and Matheran near Wayside Inn; kinking Curve Rail-Joint

- ◆ kinks at the rail-joints, especially on curves, have to be eliminated,
- ◆ on traces alongside of precipices outside protection guard-rails and on bridges inside protection guard-rails have to be provided,

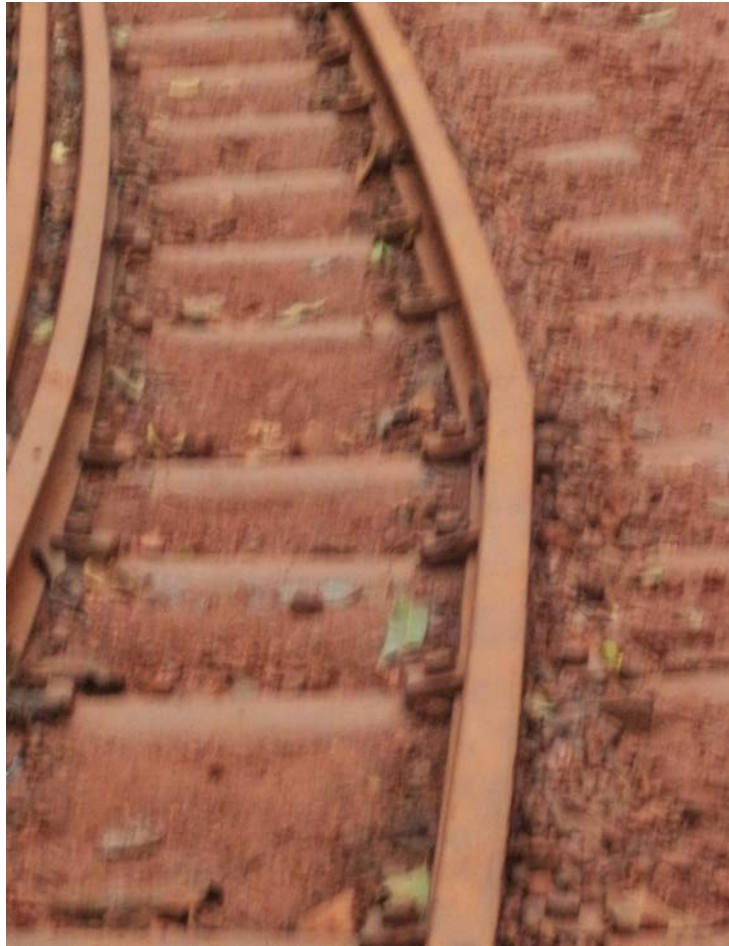
At many spots the rails are not aligned as they should be. One can detect risky and badly maintained kinks at several curve rail joints:

Kinking Rail Joint in a Curve make the Track Derailment prone

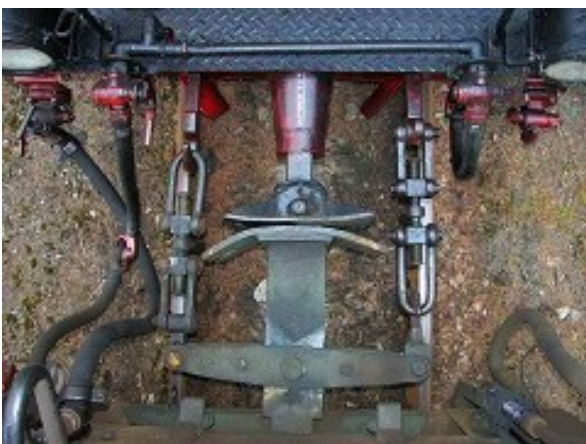
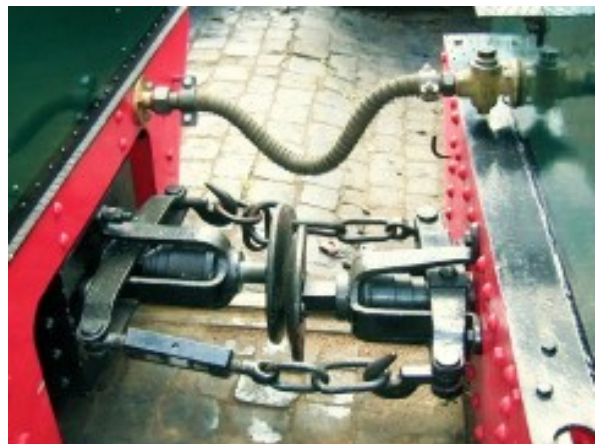
**Jerk damping German Coupling Systems for NG Train-Sets with Telescope Damper**

**The Matheran RLW rolling stocks should be provided with a jerk-free elastic coupling system, which can damp shocks and jerks:**

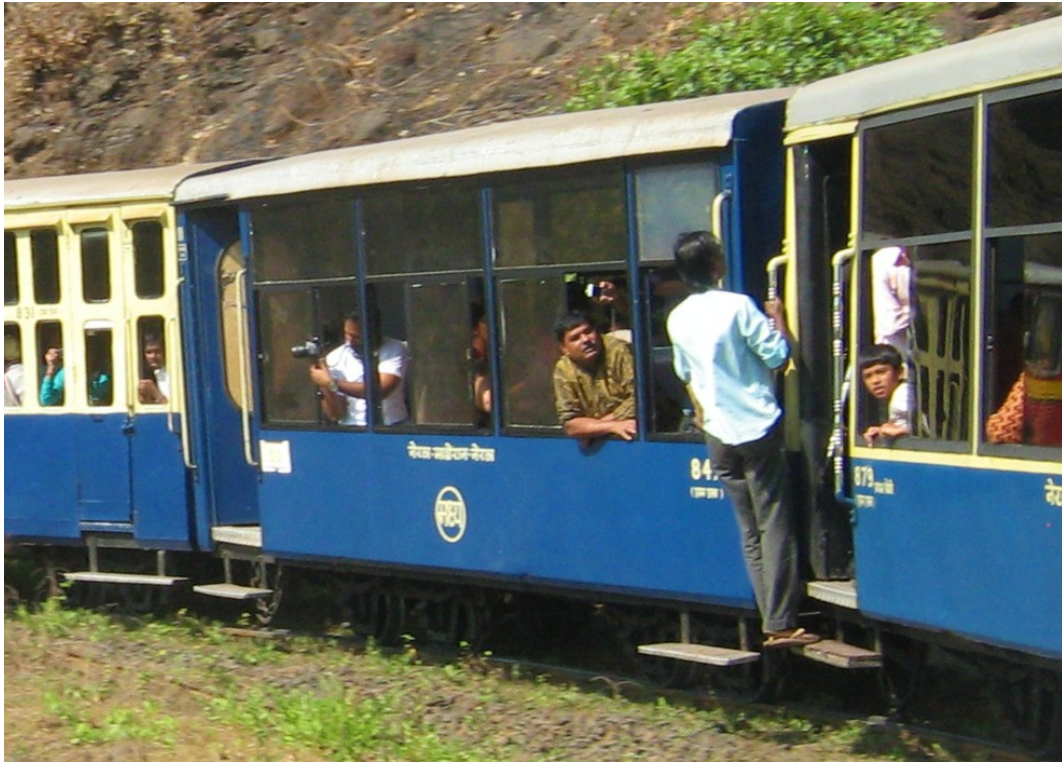
The coach brakes are operated mechanically by handbrakes with a weight-lever. The operator ("**Brake Porter**") hangs between two coaches without any safety provision or platform. Since the coaches are NOT coupled by an elastic coupling device, **JERKS** can be easily produced, if the handbrake system is not operated synchronically with the Locomotive brake. **JERKS can contribute to Derailments.**

"Brake Porter" operating the manual Coach Brake between the Coaches

The technical system must become such that the wellbeing of the passengers become independent from the skills of the "brake porters" and not put on risk by derailments caused by lapses or malfunctions of the "brake porters".

One can learn from Heritage Narrow Gauge Toy Railways in England, some of which use a **simple one-pipe, direct working compressed air-brake system without distribution valves**. The Brake Cylinders are loaded with a Spring. When compressed air is introduced into the cylinder it will work against the load-force exerted by the spring and keep the brake system in a released state. The brake is applied by gradually exhausting the air-pressure allowing the load-spring to bring the system into braking position. The system is *fall-safe*. With the drop in air pressure pipe or host in case of a rupture or leakage the brake applies mechanically. With a lever the brake can be released mechanically in case of absent of any air-pressure supply.

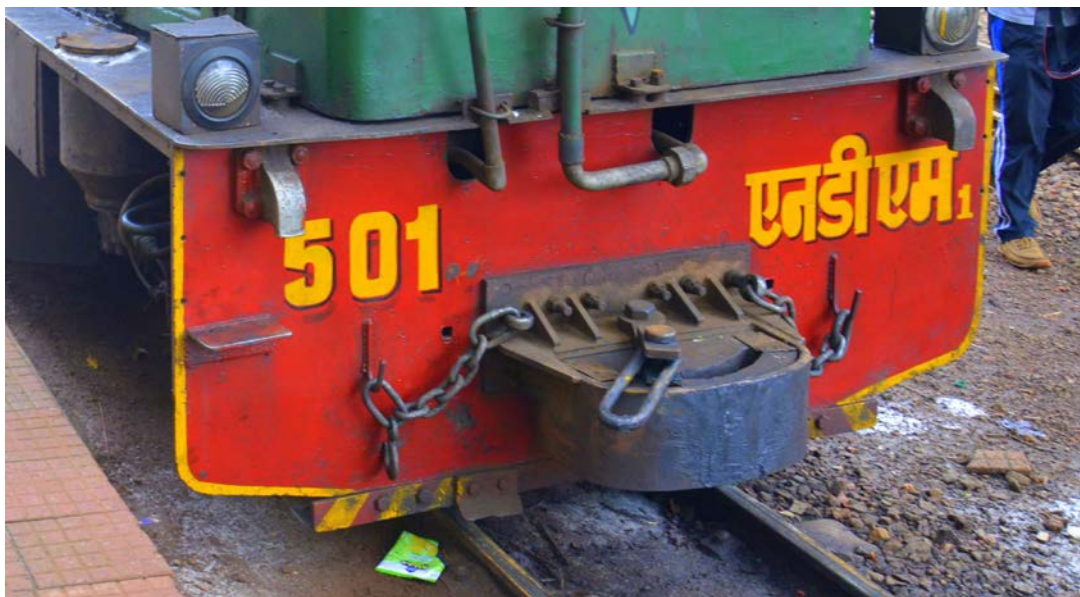
Inelastic simple Coupling Device

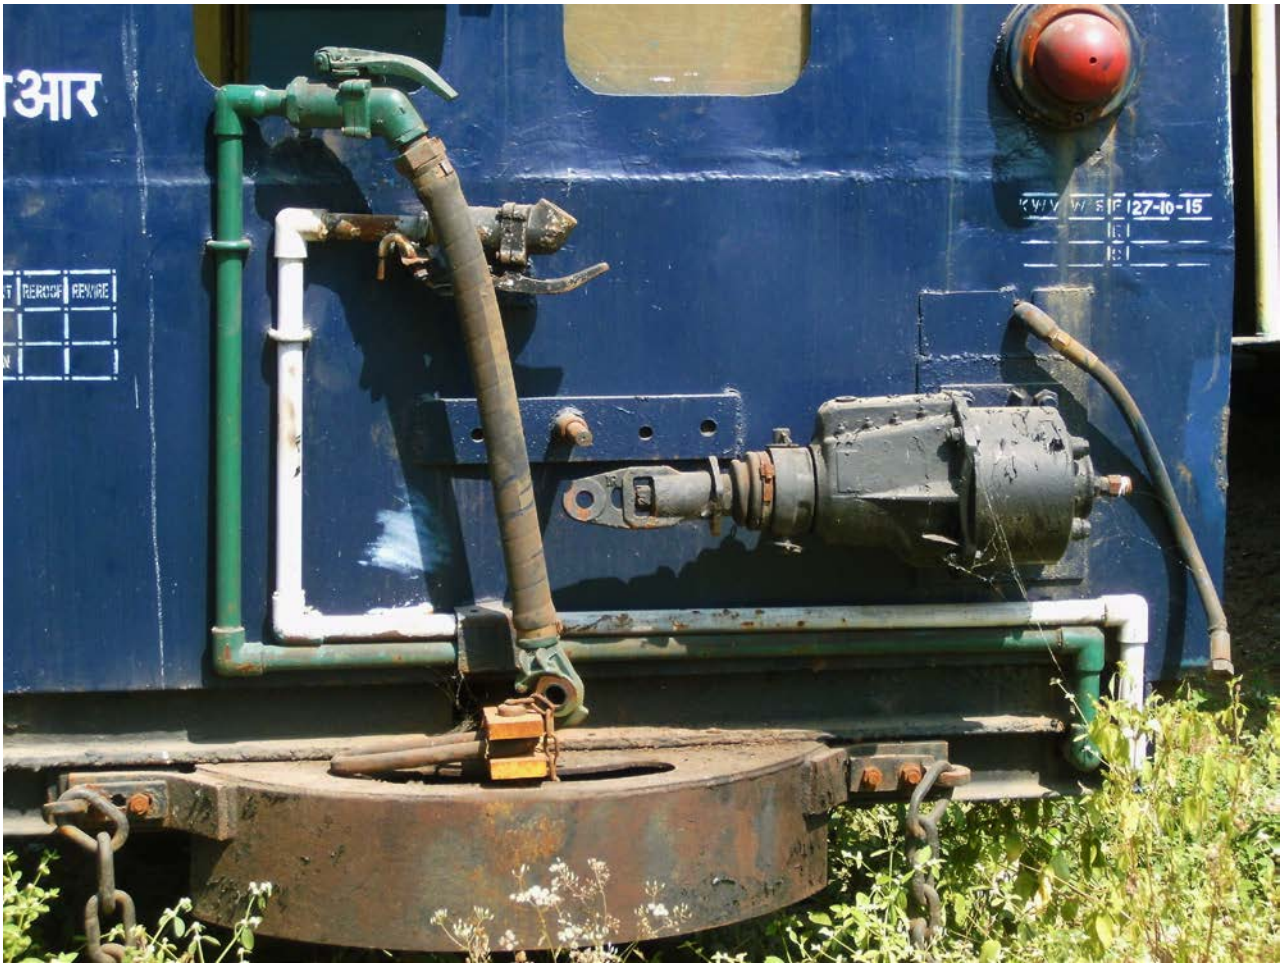
Experiments to install on the coaches the **two-pipe graduate release compressed air brakes** with brake cylinders, distribution valves and compressed air reservoirs had up-to now not successful. Such a system has to be regarded as not suitable for the small coaches under the poor maintenance, repair and test facilities, and therefore doomed to fail on this toy train. Coaches installed for trials with this system got soon vandalised for spare parts. For the needs to service, maintain, repair, test and check with brake certificates; see P.C. GUPTA: **AIR BRAKE SYSTEM GUIDE**, 5<sup>th</sup> Edition 2006, available at Jain Book Agency, New Delhi, JBA Book Code 5537, 150 Rupees.

Vandalised Dual-Pipe Compressed Air Brake Components at Neral

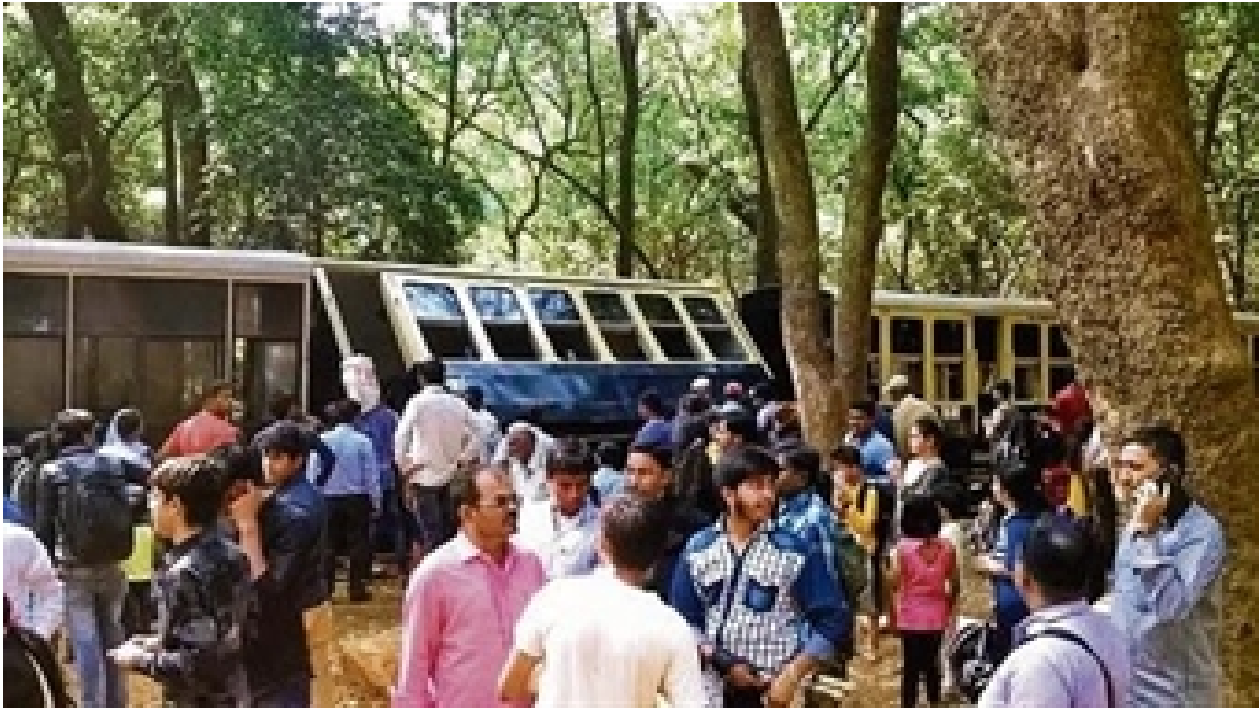
For Safety Reasons, one has to become independent from possible lapses and malfunctions of the hand-brake operators, who can easily produce jerks contributing to derailments, like recently at Aman Lodge,

01.05.16 Aman Lodge Derailment

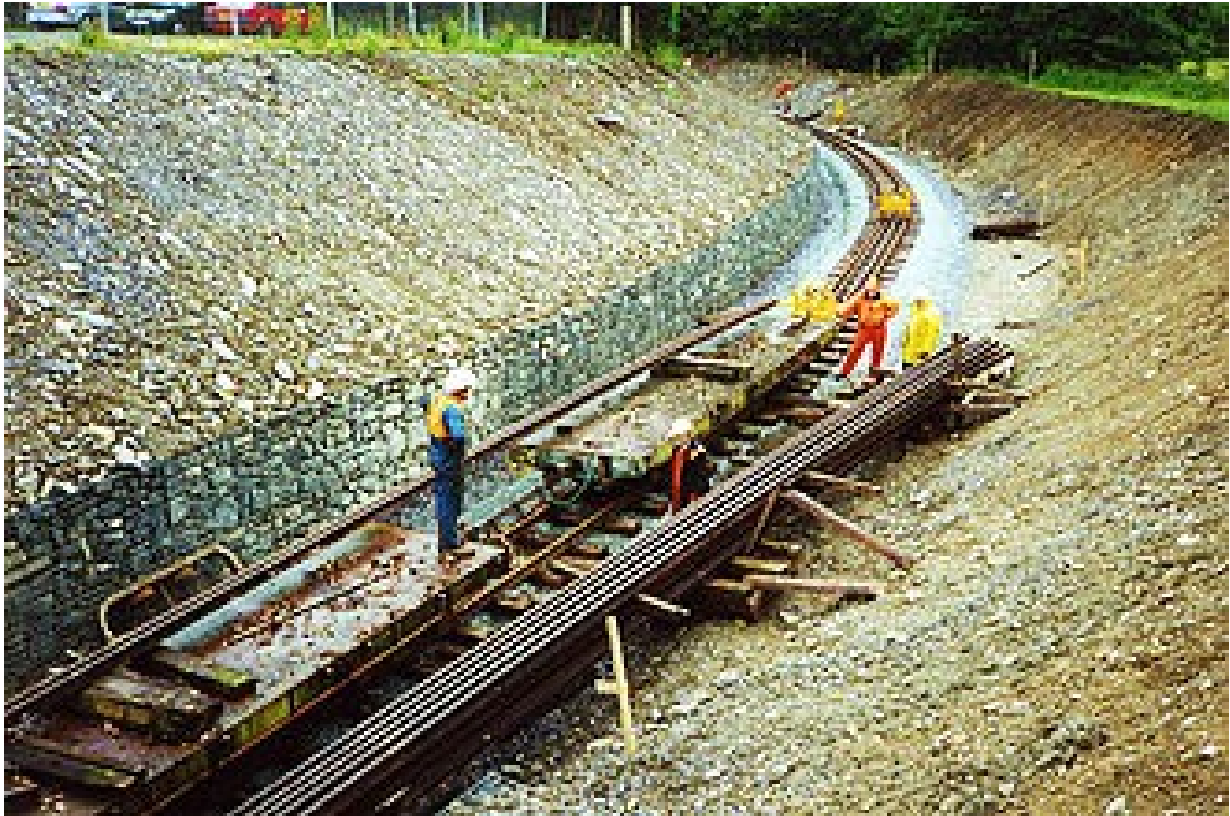
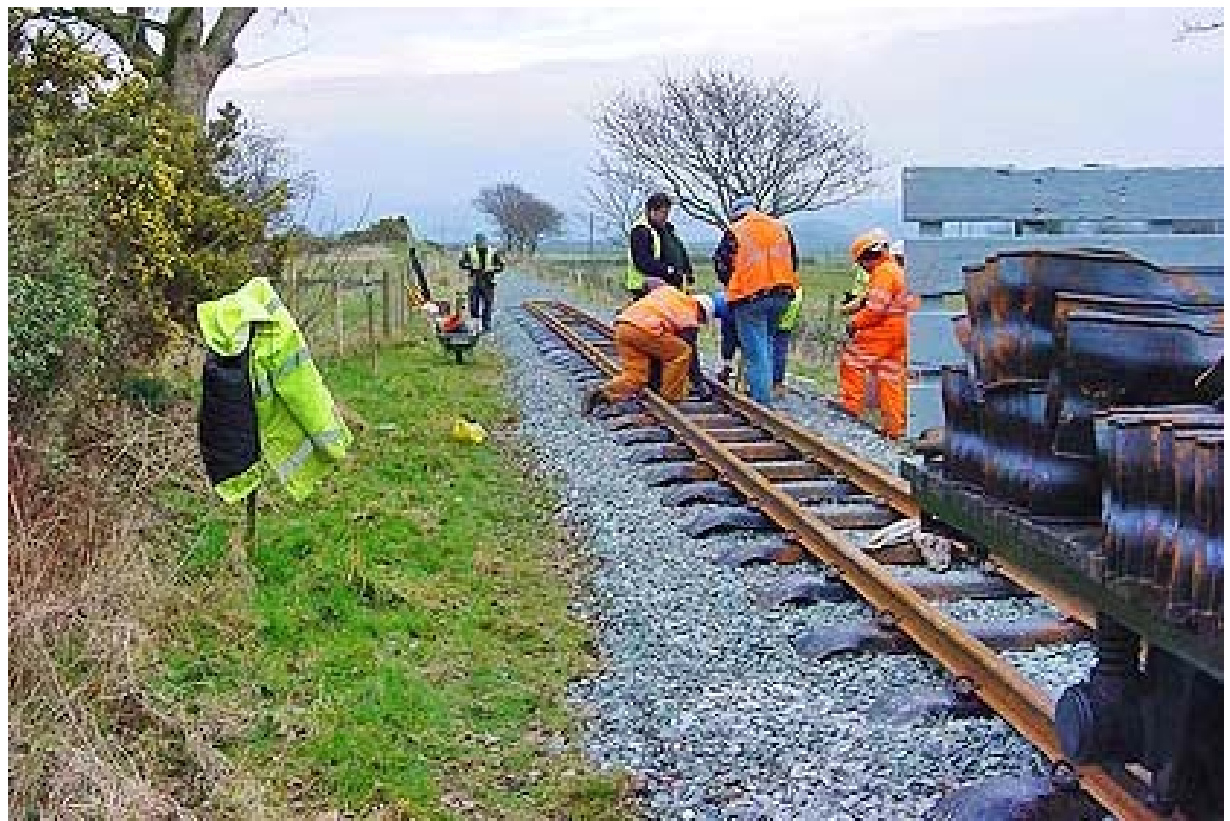
How a 2 ft NG rail-track can be laid with trough steel-sleepers on a well ballasted cushion for safe passengers service can be learned from the UK, North Wales, 25 miles long nostalgic and scenic **WELSH HIGHLAND RAILWAY**, which had been recently rebuild and revamped (see also the Technical Railway Paper by Dr. F.A. Wingler **RAIL TRACK GEOMETRY** under <http://www.drwingler.com>):

Laying 2 ft. NG Rail Track on Trough Steel-Sleepers on a well ballasted Formation;  
Welsh Highland Scenic Railway, Wales, England
