# **Matheran`s Toy Train - the Joy and Pride of Maharashtra, India**

## **Goodbye to Matheran's Toy Train?**

**Feature Article by  
Dr. Frank August Wingler, Germany**

**Matheran October 2016  
Revised November 2016**

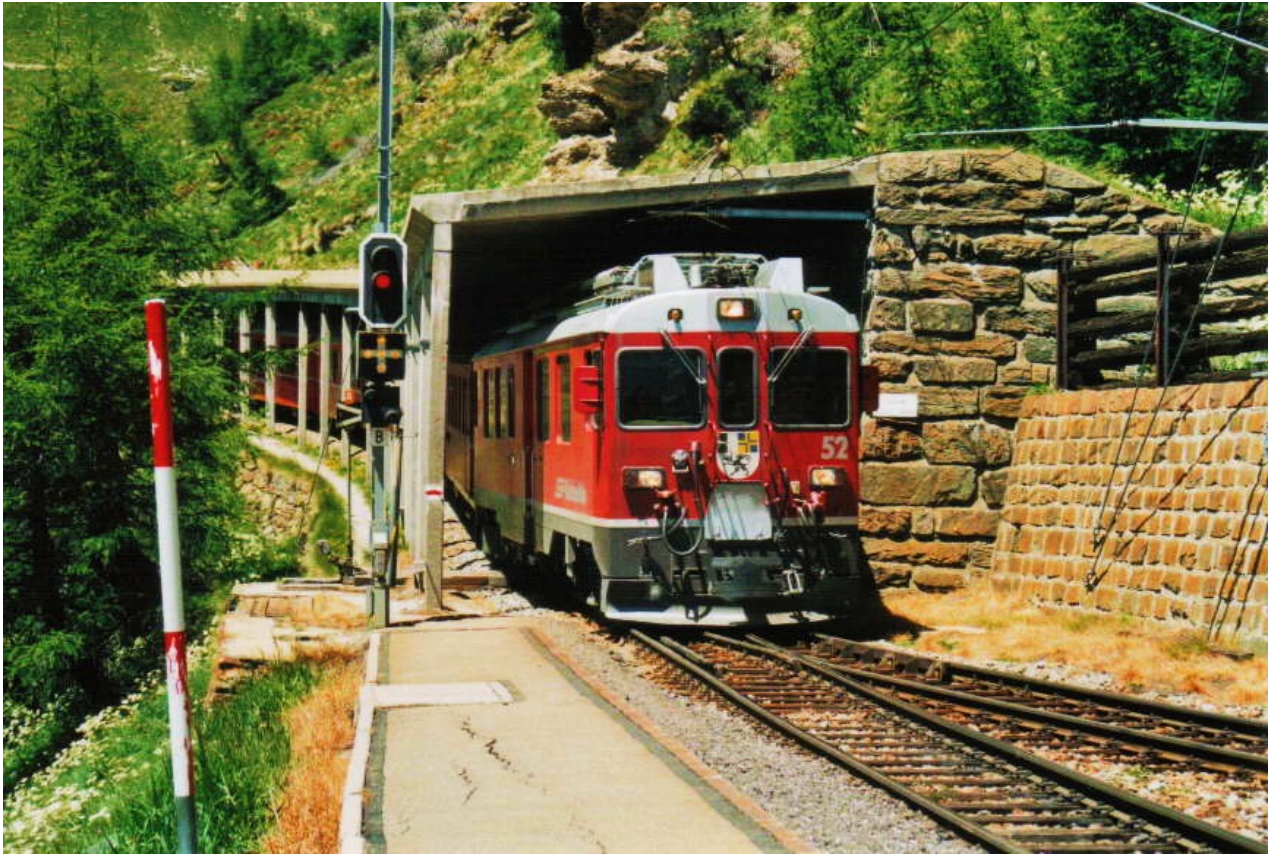
On risky sections along the precipices as around the Panorama-Point/Mt.Berry/Governor Hill Rim the track-trace should be shifted towards the hillside and the track run through Protection-Galleries as can be seen on the following picture of the alpine St. Bernina Railway in Switzerland:

Protection-Gallery, Bernina Railway, Switzerland

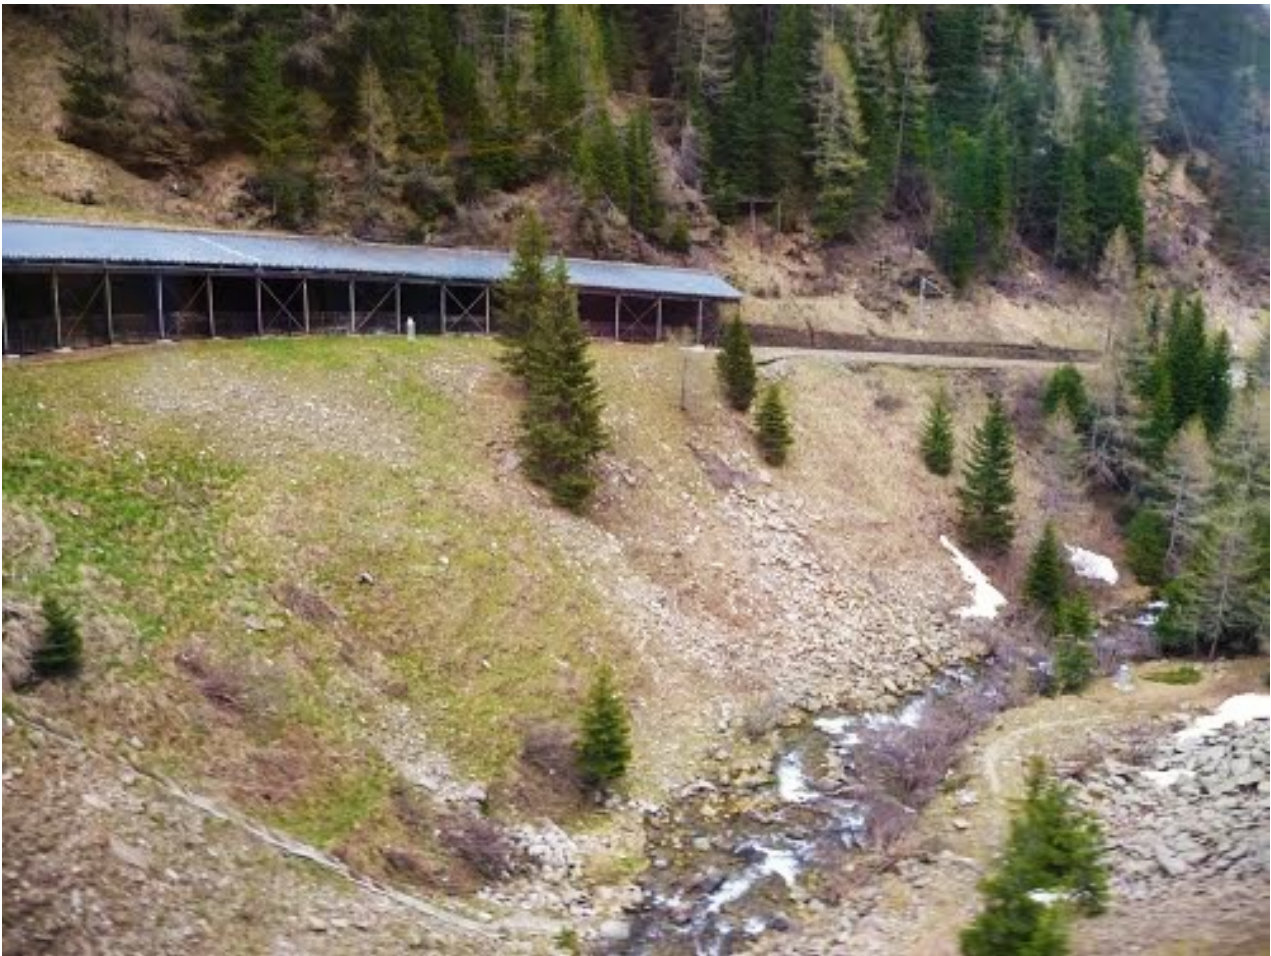
Protection-Gallery, Bernina Railway, Switzerland

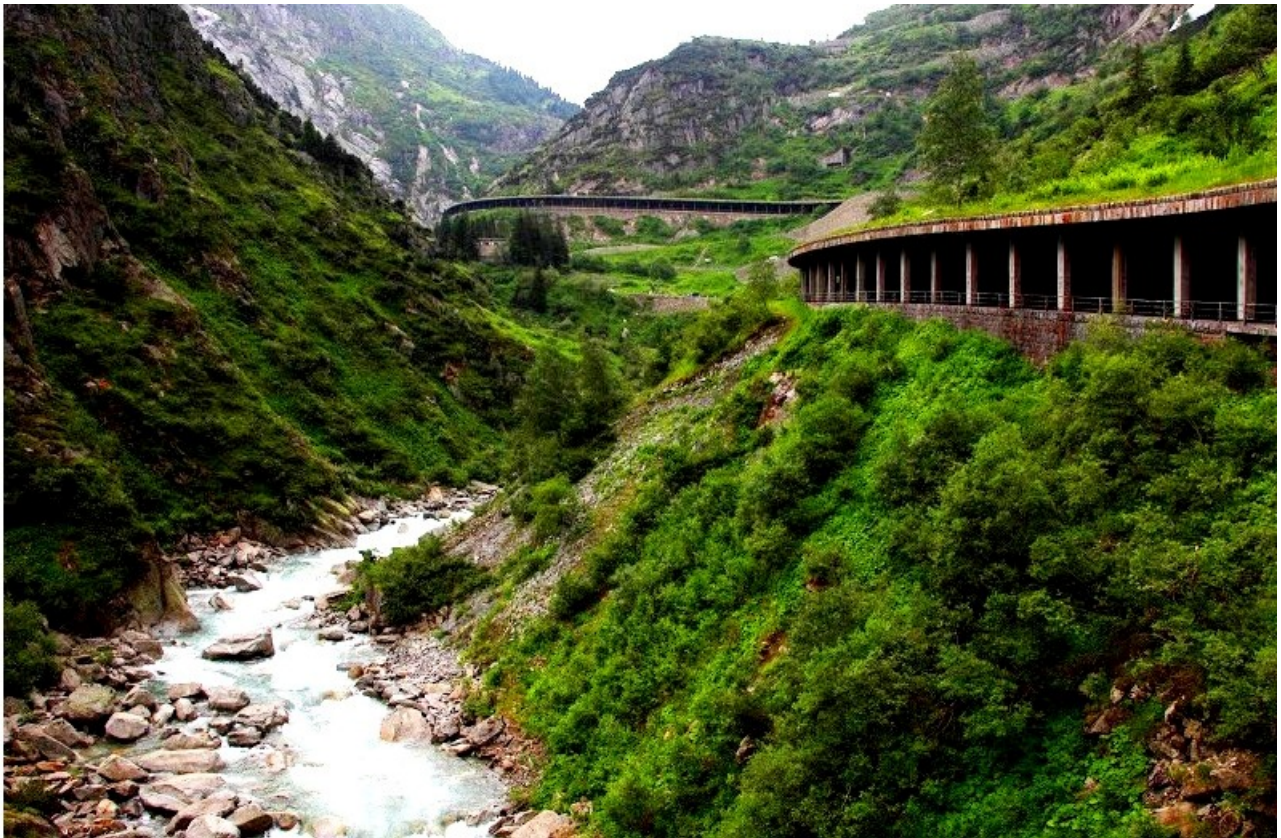
Protection-Gallery; Schöllenen Gorge, Switzerland

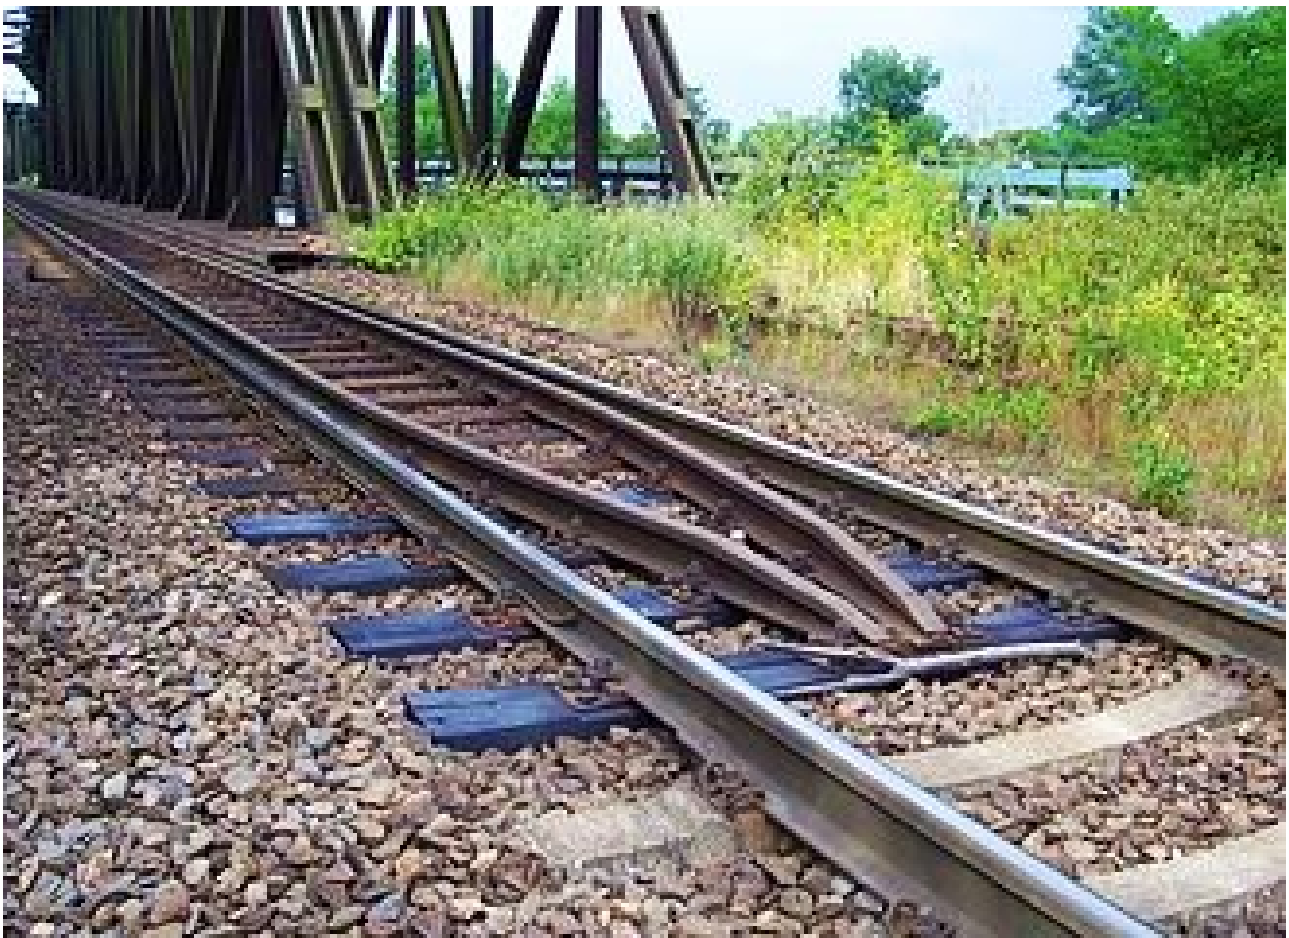
Derailment-Protection at Bridge by Guard-Rails

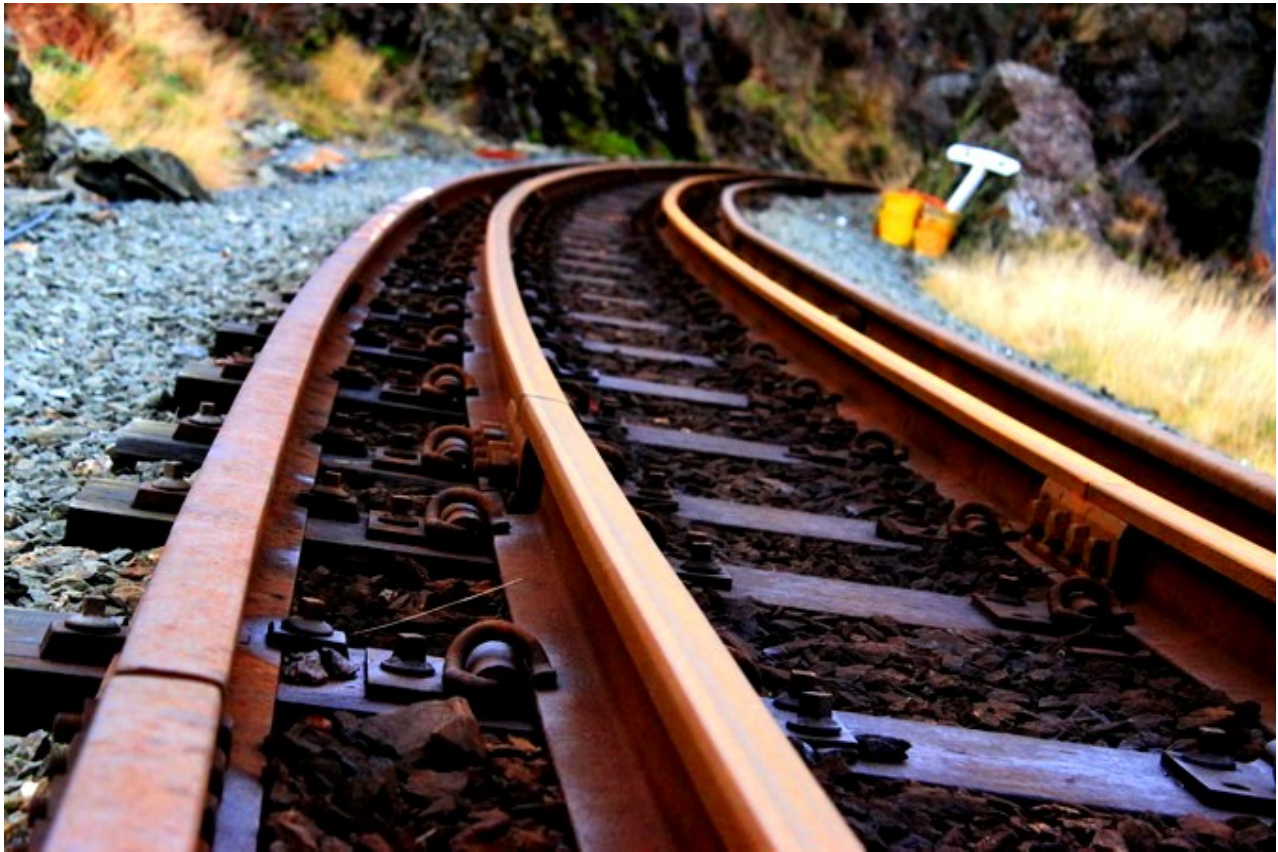
Protection at Precipices by outside Guard-Rails on 2 ft. NG scenic Festiniog Railway, Wales, England

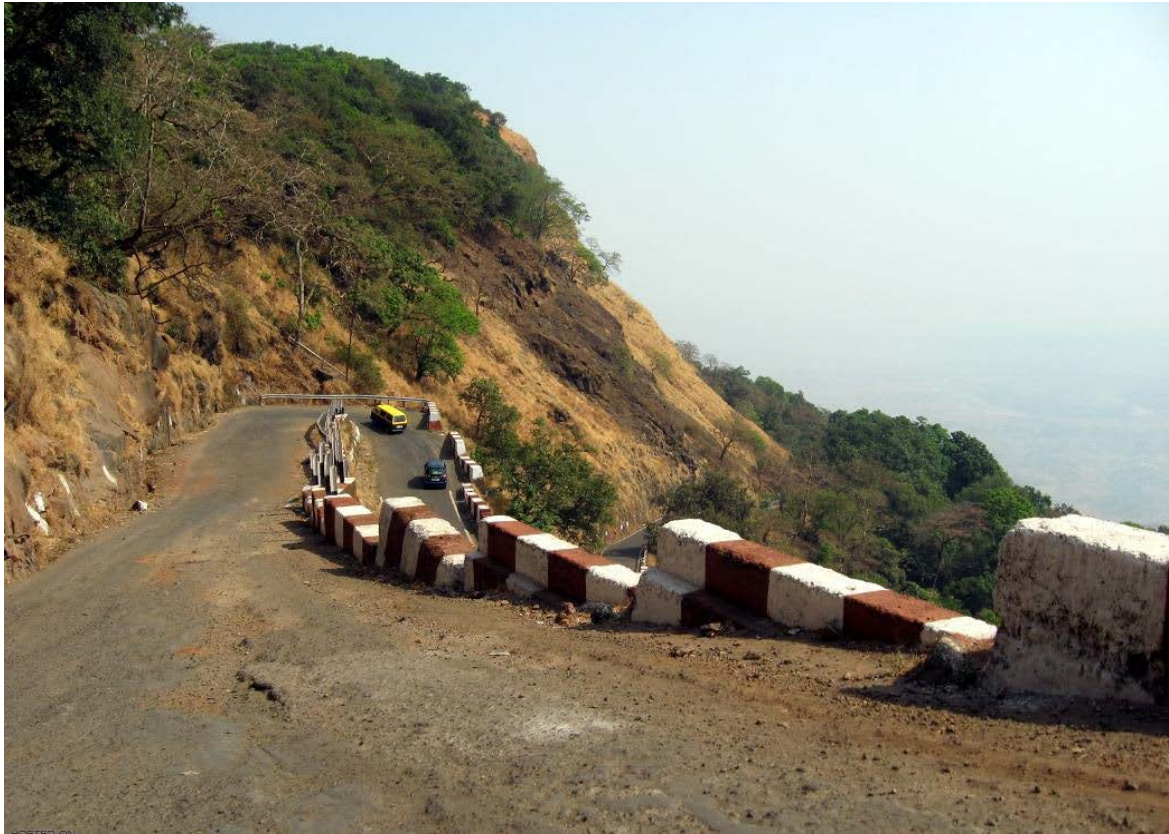
For the social-economic wellbeing of the unique ecological hill-station **MATHERAN** a proper road access is essential. Of the Neral-Matheran road access, the risky, steep and curvy section between Jhumpati and the point of entrance to the municipal at Dasturi is mostly in a deplorable state-of-affairs:

Risky Road Access to Matheran; mostly in a deplorable State-of-Affairs

Most urgent are a proper all-season-stable well drained stable and safe tar-road access and a proper carpark at Dasturi, even if for a proper and stable infrastructure a small part of the forest has to be sacrificed.

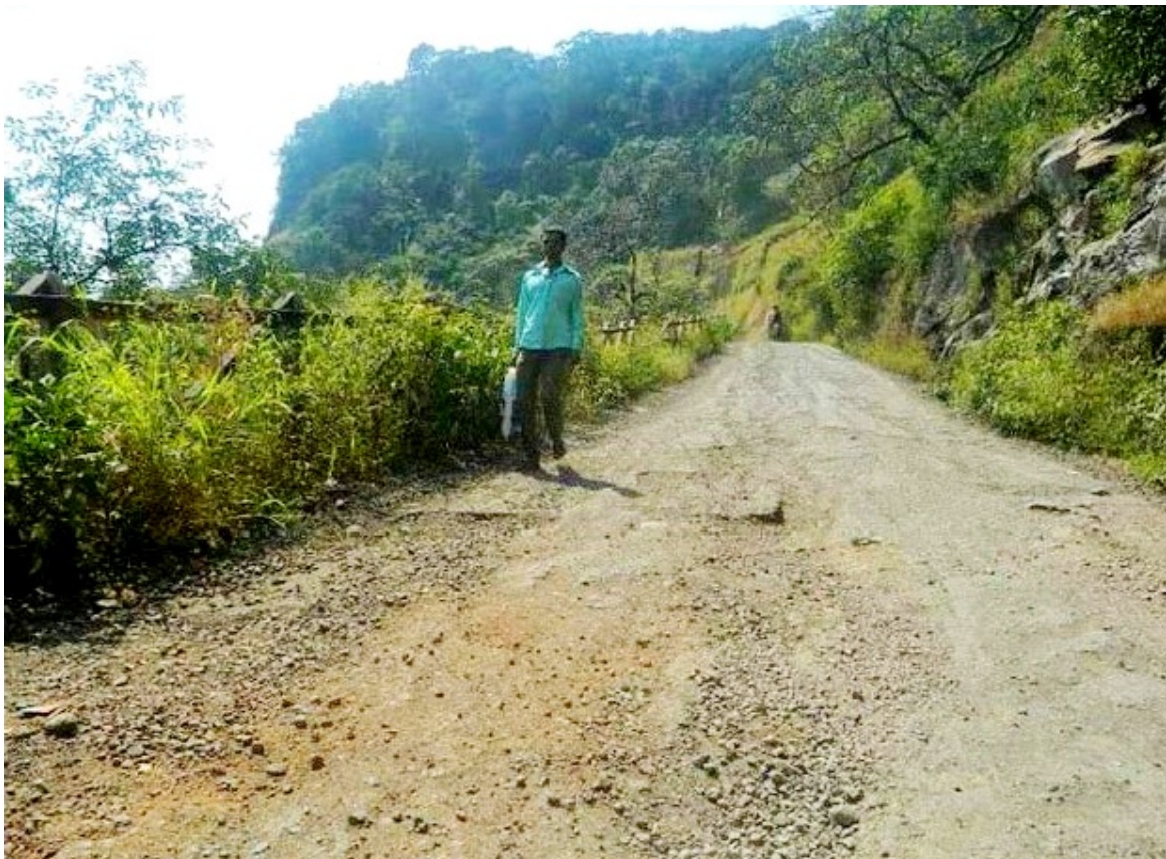
Neral-Matheran Road, risky and mostly in a deplorable State-of Affairs

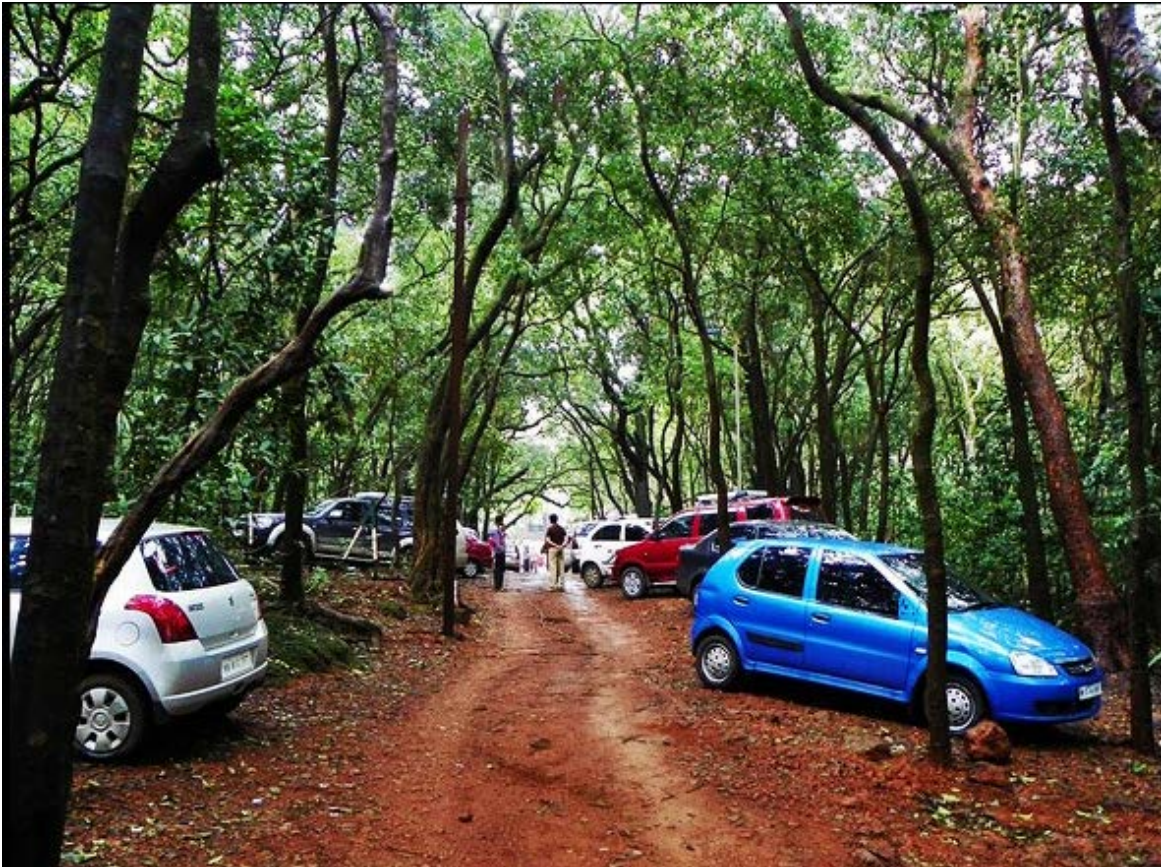
There is no proper carpark for the numerous taxis and frequent visitors coming by their own road vehicles, neither at Neral nor at Dasturi. Cars are parked at Dasturi in the forest and even on the trail to Panorama Point; at Neral the Taxis block the roads:

Visitors park their Cars in the Forest on the Trail to Panorama Point

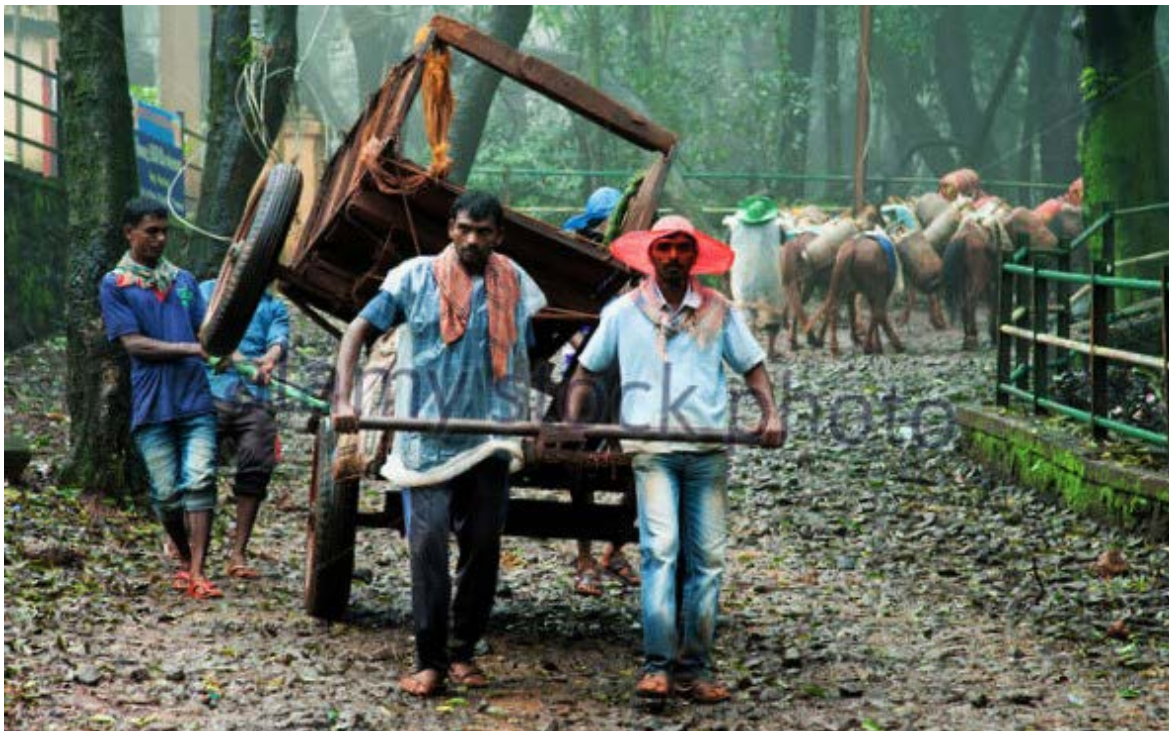
Between Dasturi and Matheran-Market there is a steep unfortified cart-road, which turns during rainy season in a mud path and during dry season in a rough and stony dust-fuming trail. Coolies have to take unbearable pain to push up heavy load on their hand-carts:

Coolies with Hand-Cart and Carrier-Horses

A road stabilisation with a sturdy pavement resisting the climate situations, enabling an all-season smooth and easy movement of the delivery hand-carts and customer rickshaws is of utmost priority. Such a stable road could also be used by pedestrians, who nowadays take their footway from Dasturi to the Market over the rail-track trampling down the formation and ruining the embankment:

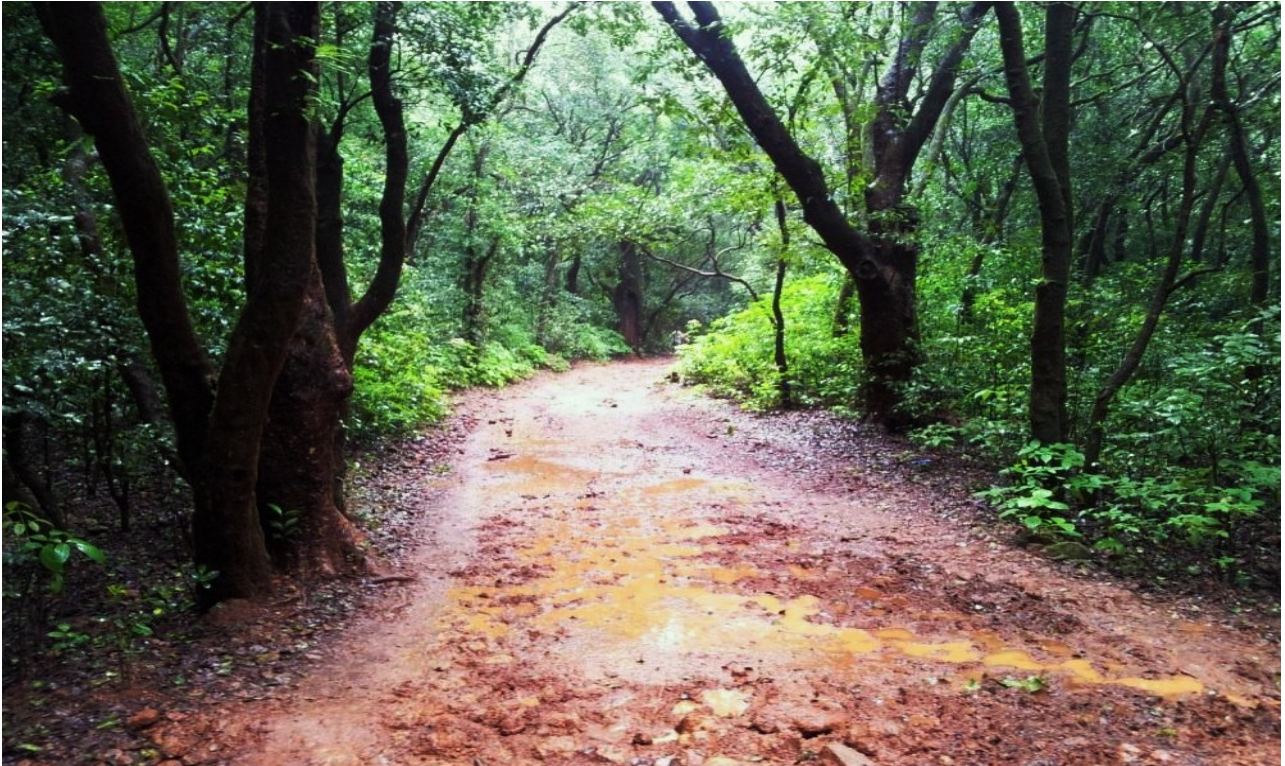
Unfortified Dasturi Matheran-Market Cart-Road in a deplorable State-of-Affairs

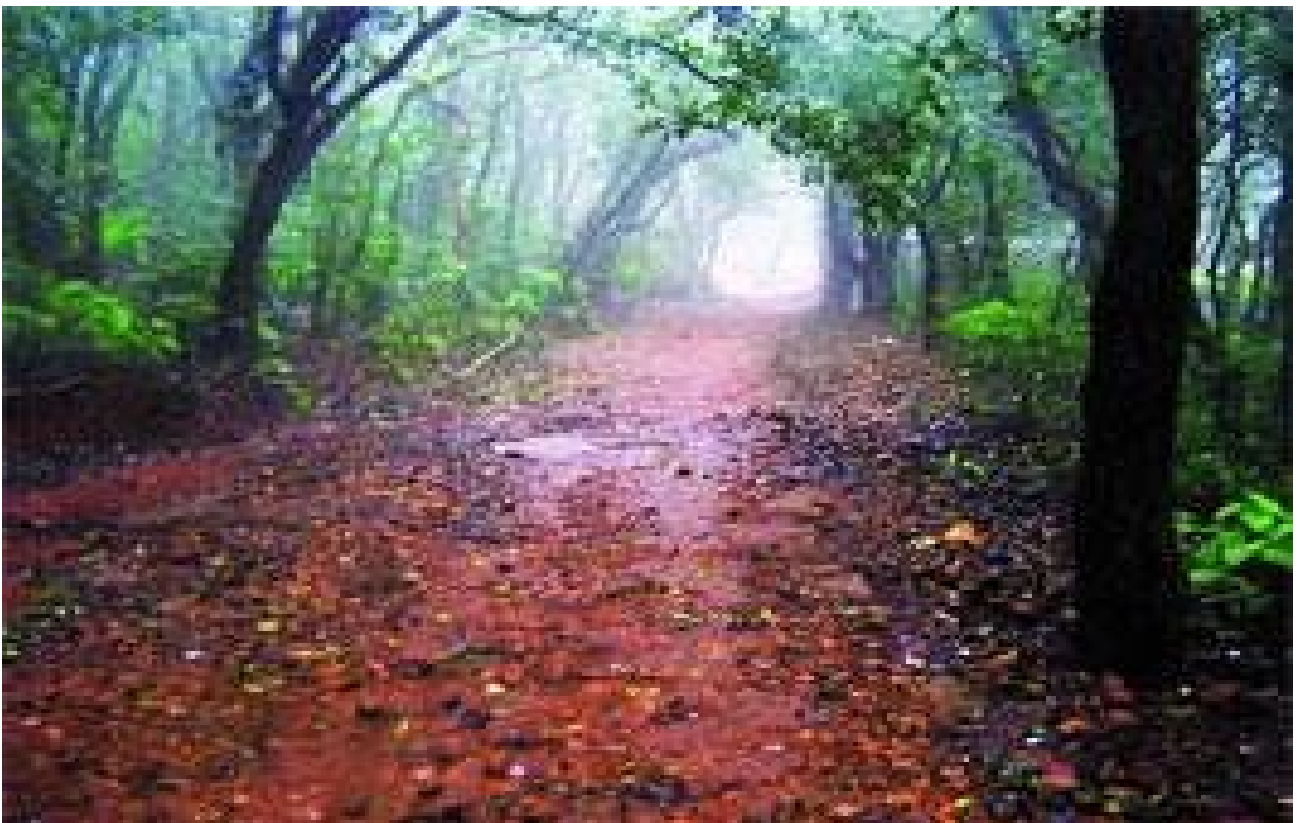
Unfortified Dasturi Matheran-Market Cart-Road in a deplorable State-of-Affairs

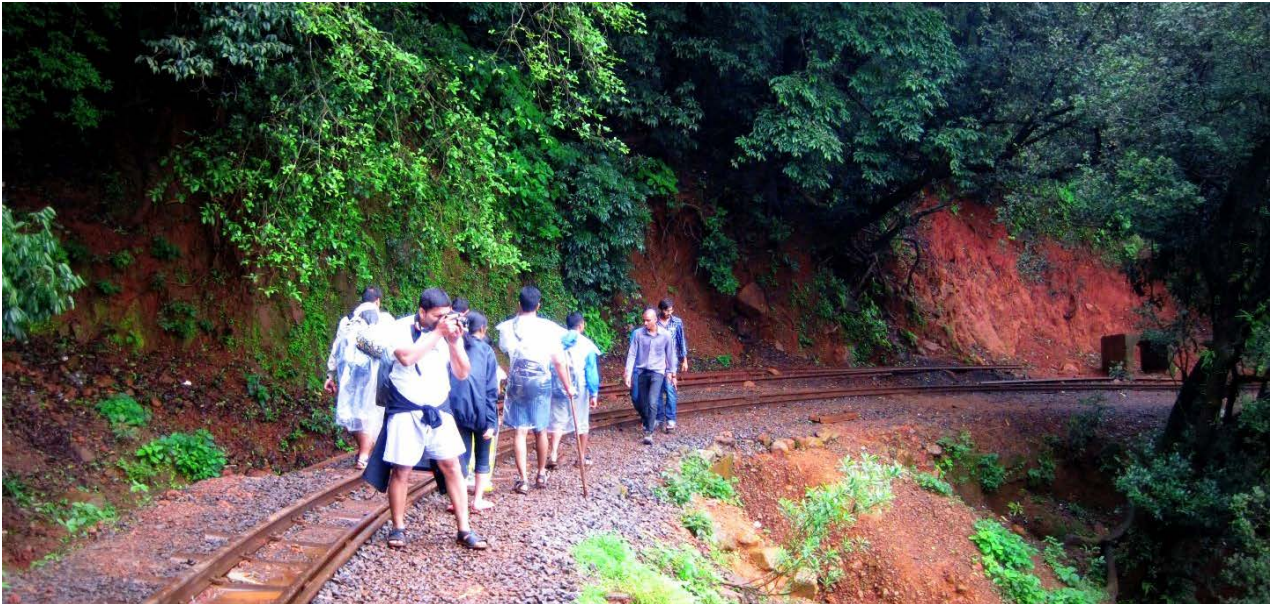
Pedestrians using the Rail Track along the Abyss as a Trail to Matheran

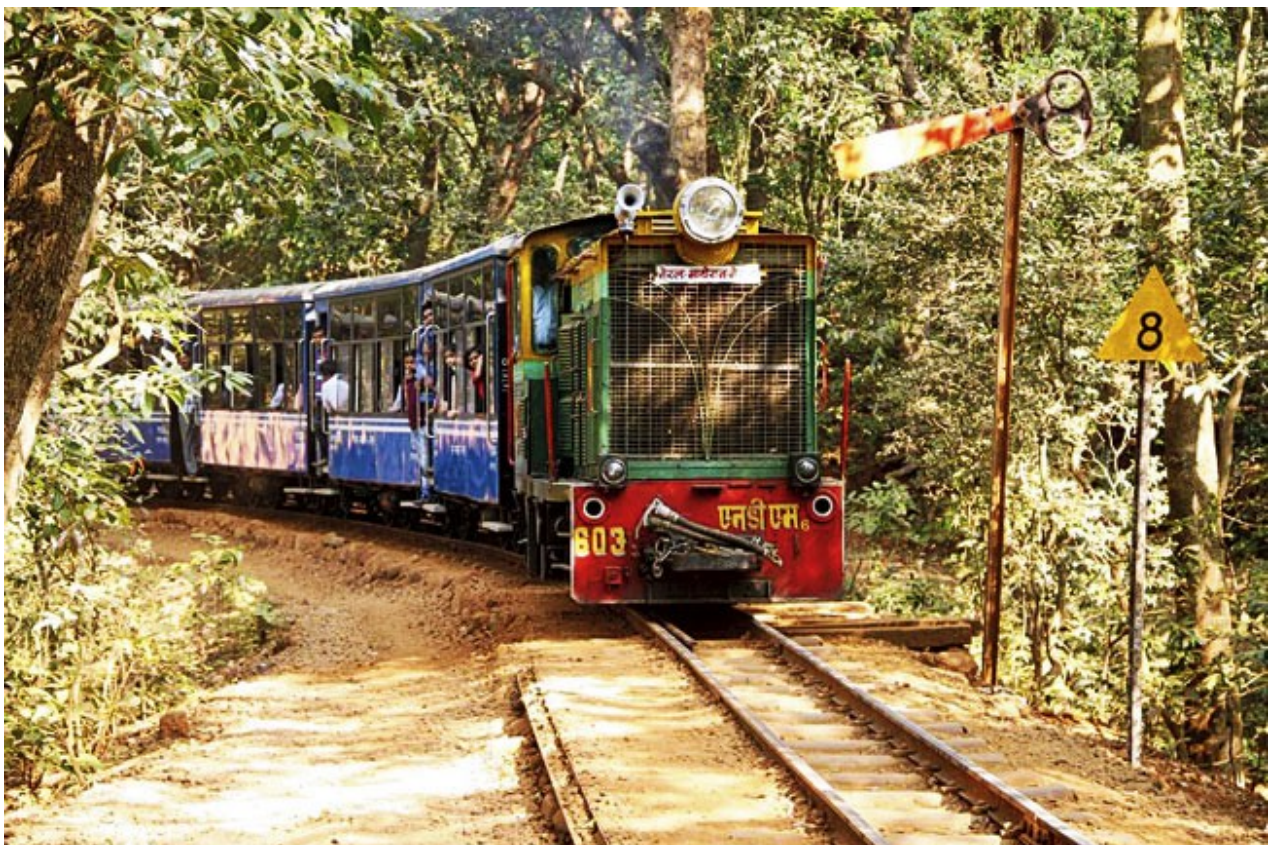
In the last years there had been a so-called **“Shuttle-Service”** provided on rail between Aman Loge and Matheran Railway Station. This shuttle had been operated with two Diesel locomotives in push-pull formation. To run this short shuttle service a huge number of personnel is needed. Since at Matheran there is no loco shed or repair/maintenance workshop and no facility to fuel the locomotives, every evening one locomotive has to be brought down to Neral for service, maintenance, repairs and checking, and one locomotive in ready fuelled and workable condition has to be brought up the next morning:

Shuttle Service chuckling from Matheran to Aman Lodge

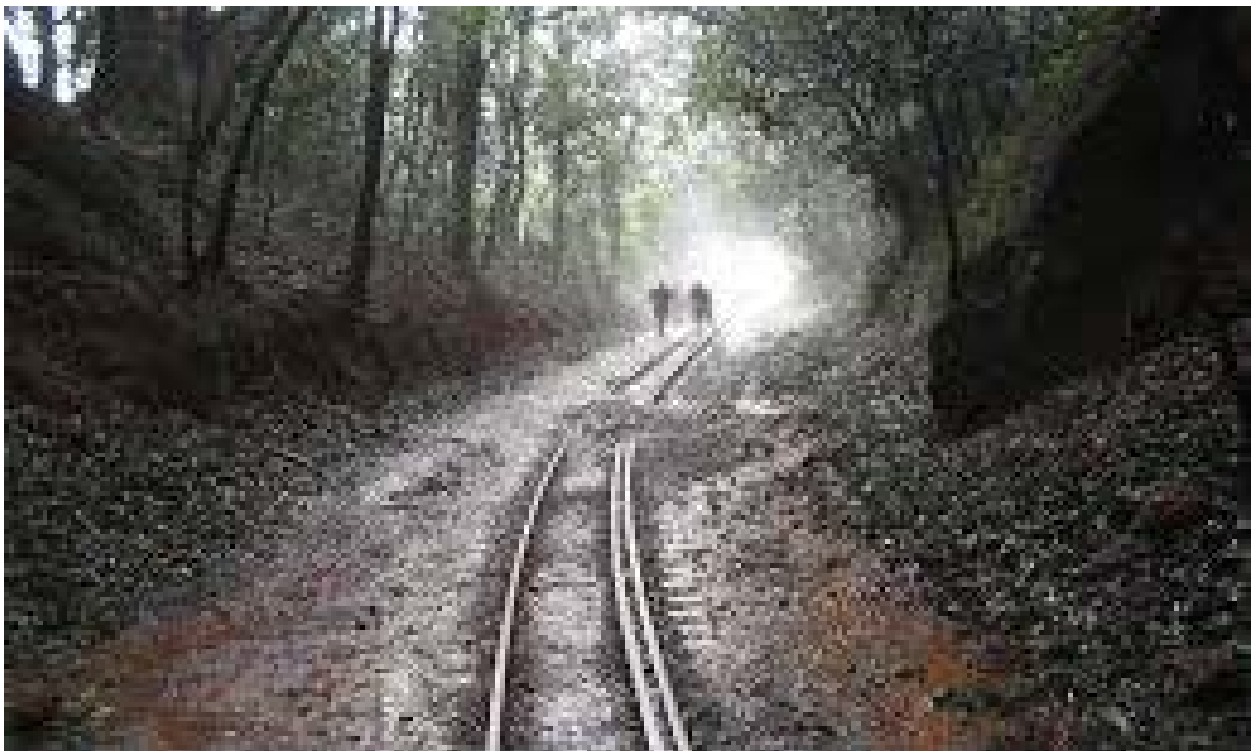
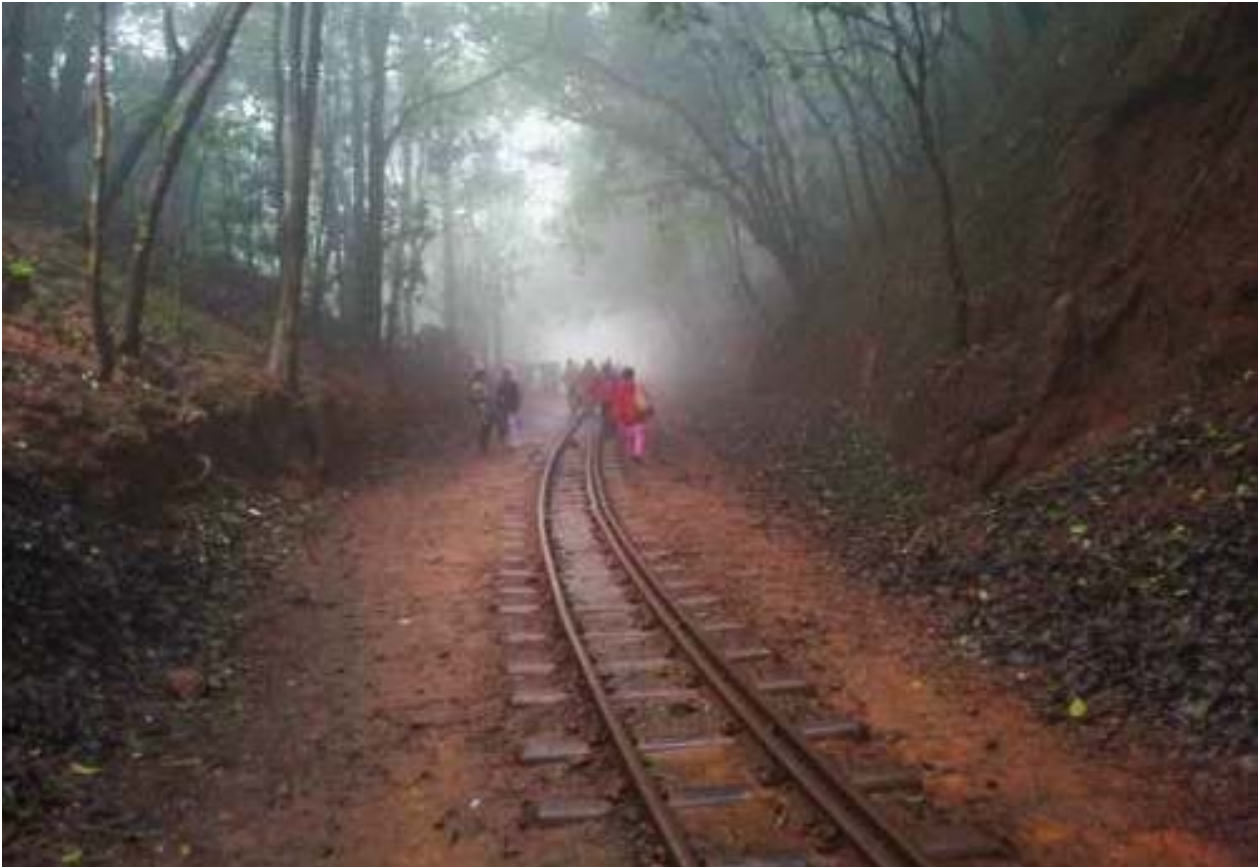
Aman Lodge – Matheran Trace could be converted into a dedicated Horse-Trail

The **FUTURE** of this Joy and Pride of India`s tourism is brim. In case this Heritage Toy Train will go down the **MEMORY LINE**, the rail-trace between Dasturi and Matheran could be converted into a dedicated **HORSE TRAIL** segregated from the **Hand-Cart** and **Rickshaw Road**:
